# Pleasure Creek

**Excerpted from  
Pleasure Creek Inspection Report**

**Coon Creek Watershed District  
June 1, 2012**

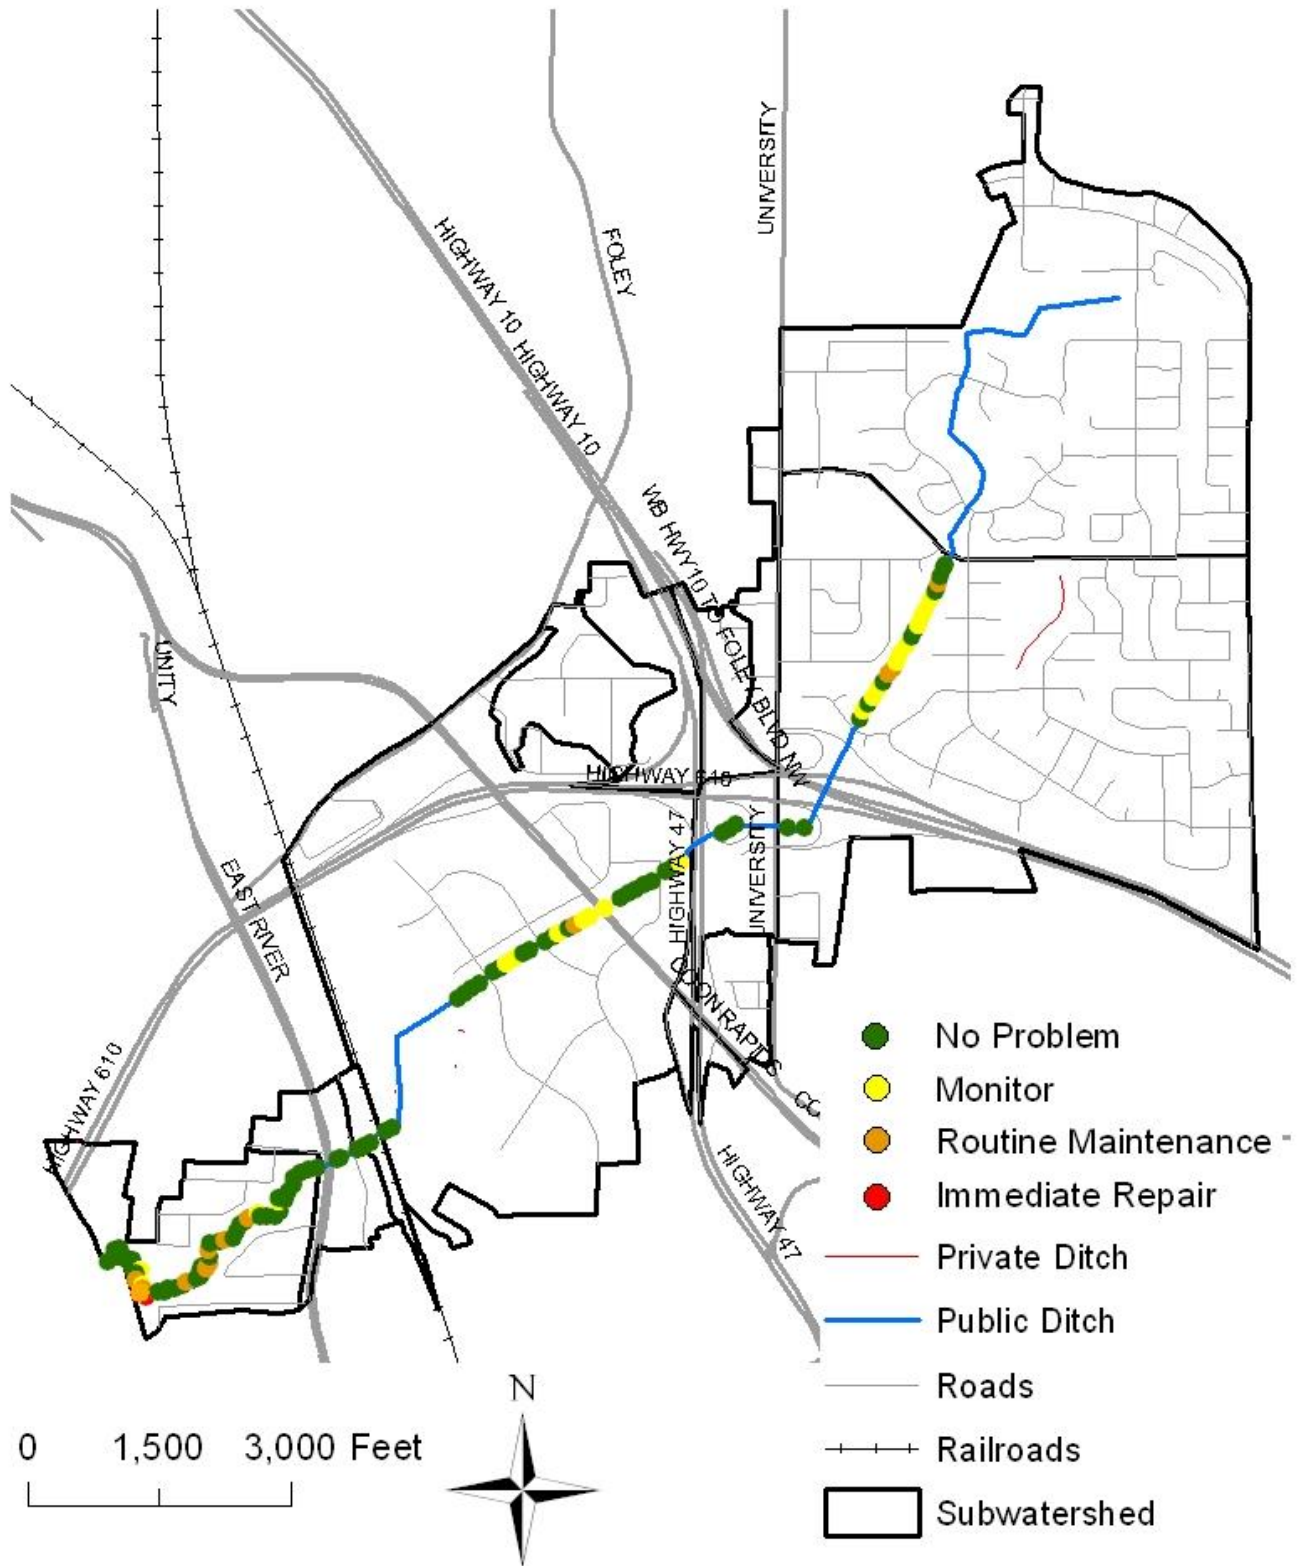
**Figure 2:** Pleasure Creek channel condition.  
 Values resemble conditions at time of survey.

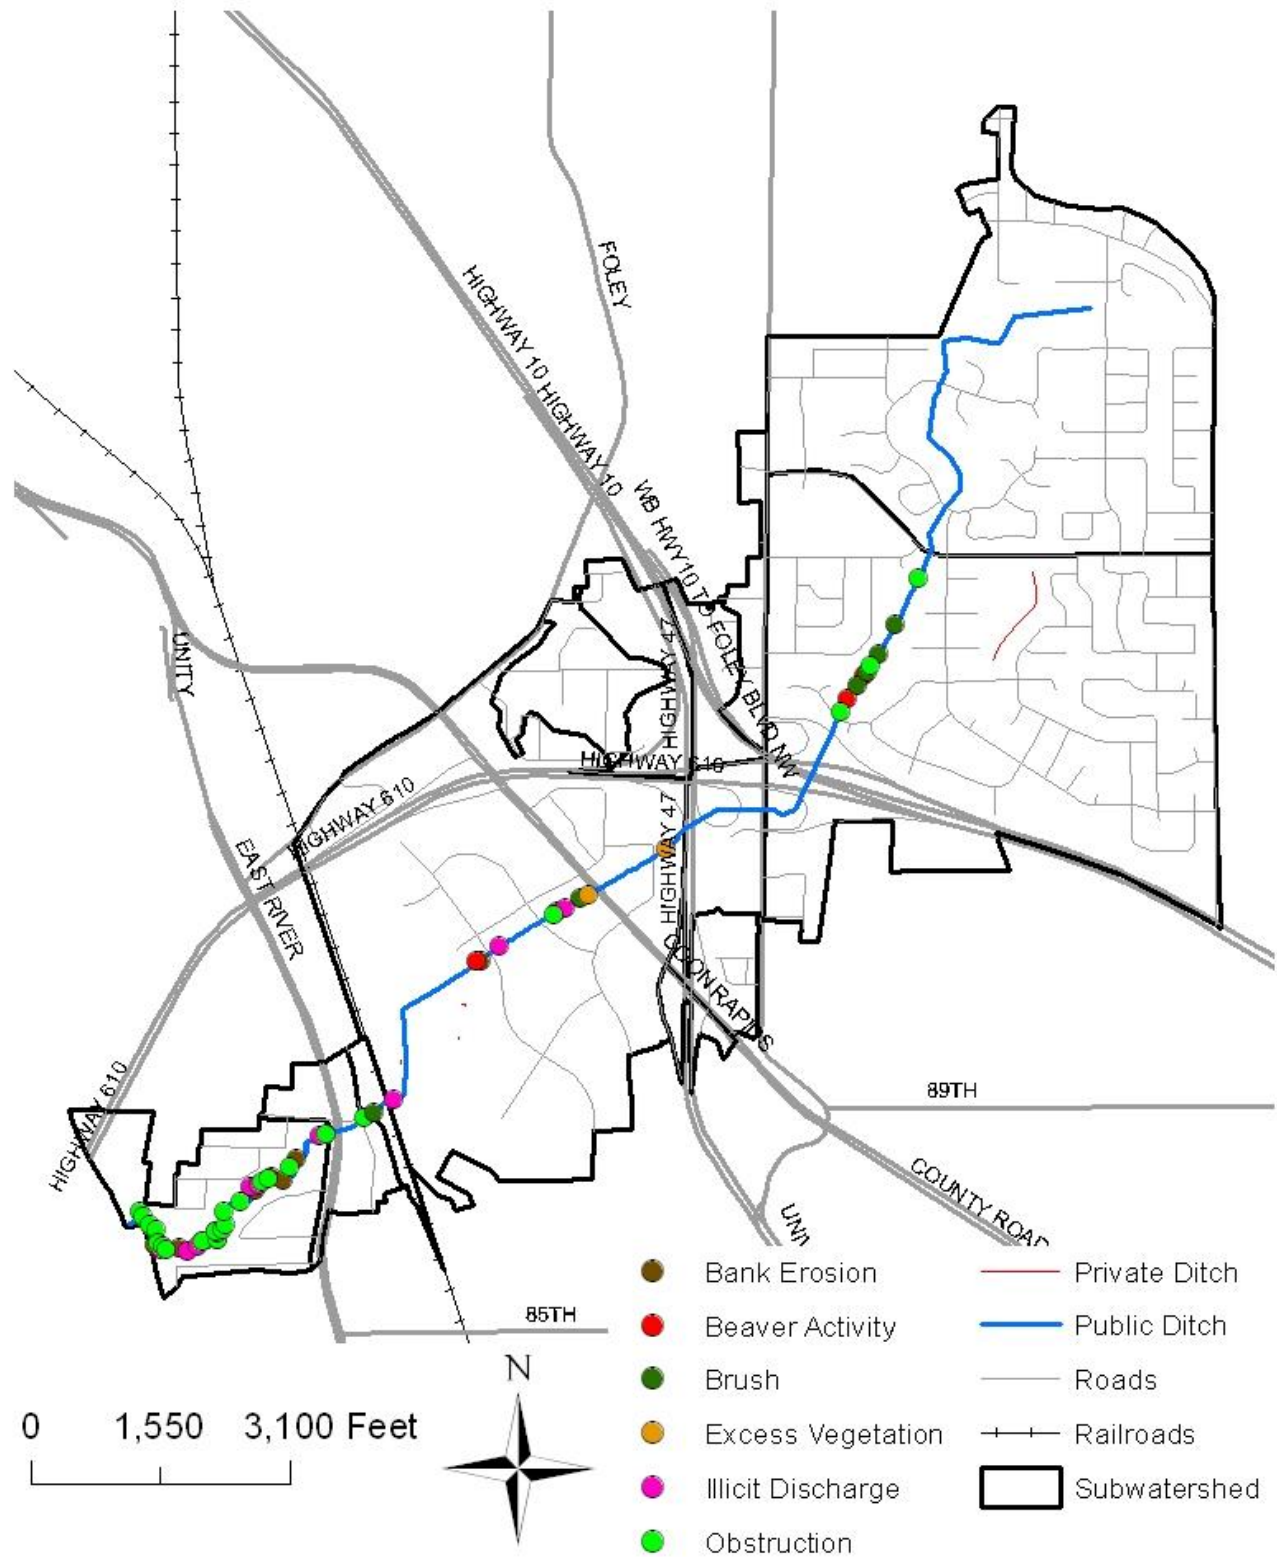
**Figure 3:** Pleasure Creek maintenance needs  
 Values resemble conditions at time of survey.

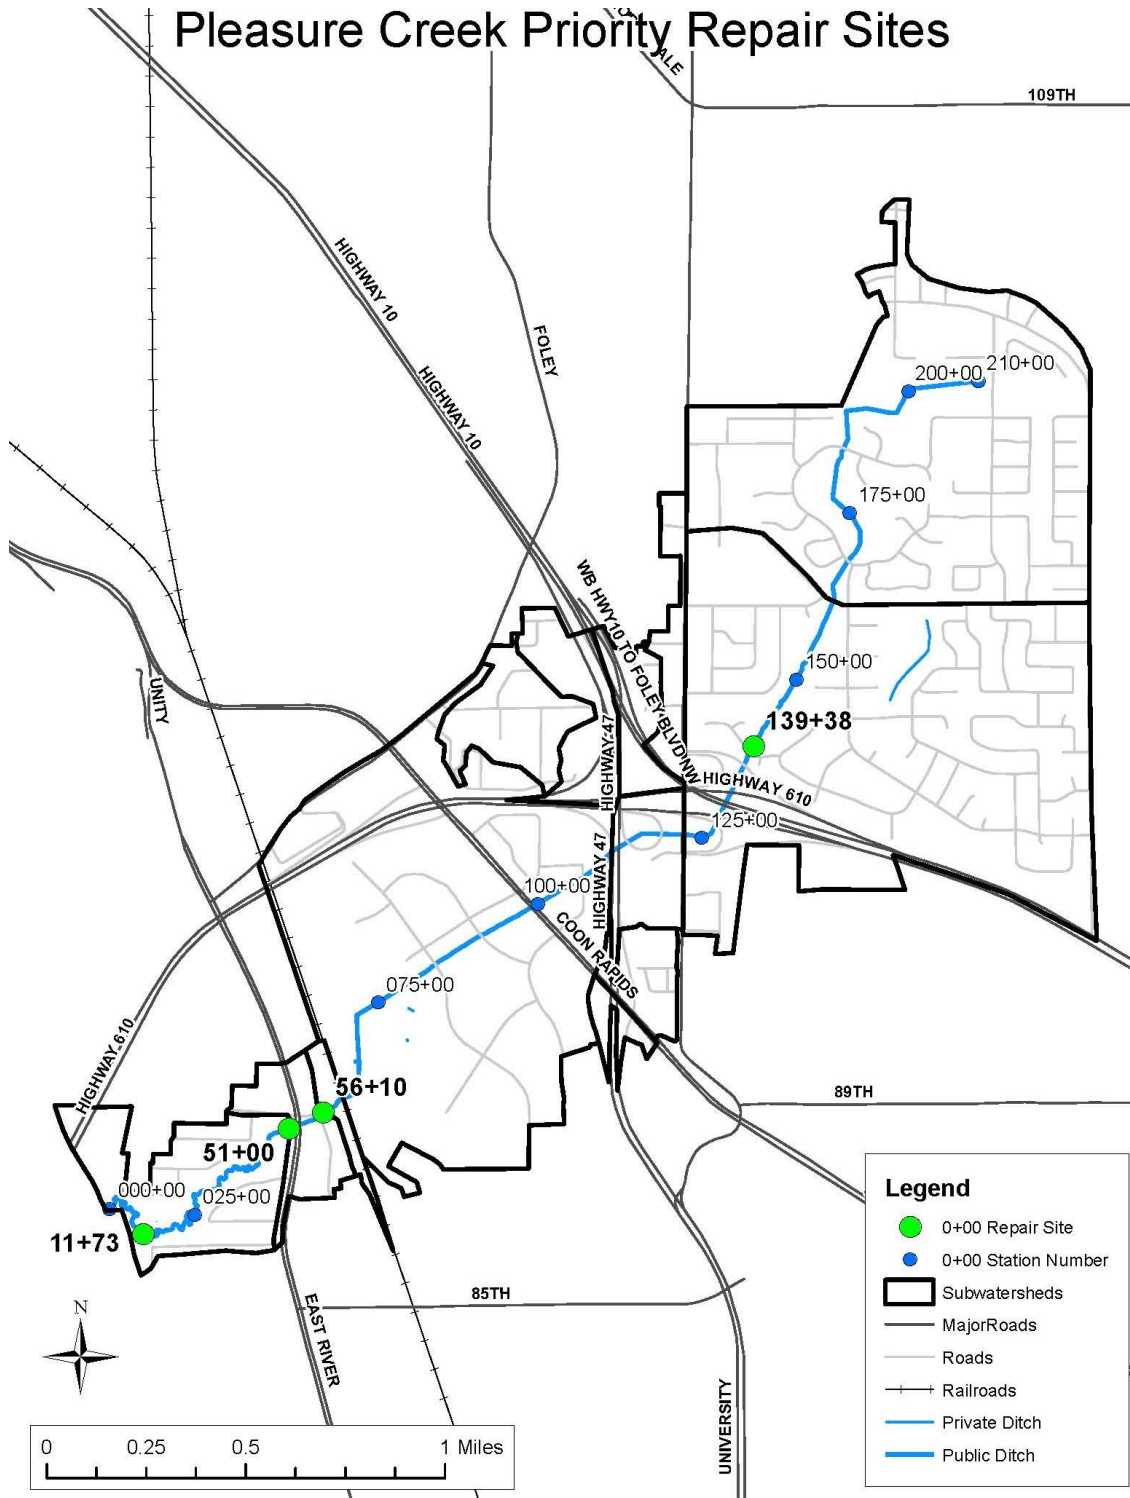
**Figure 4:** Pleasure Creek priority repair sites.  
 Values resemble conditions at time of survey.

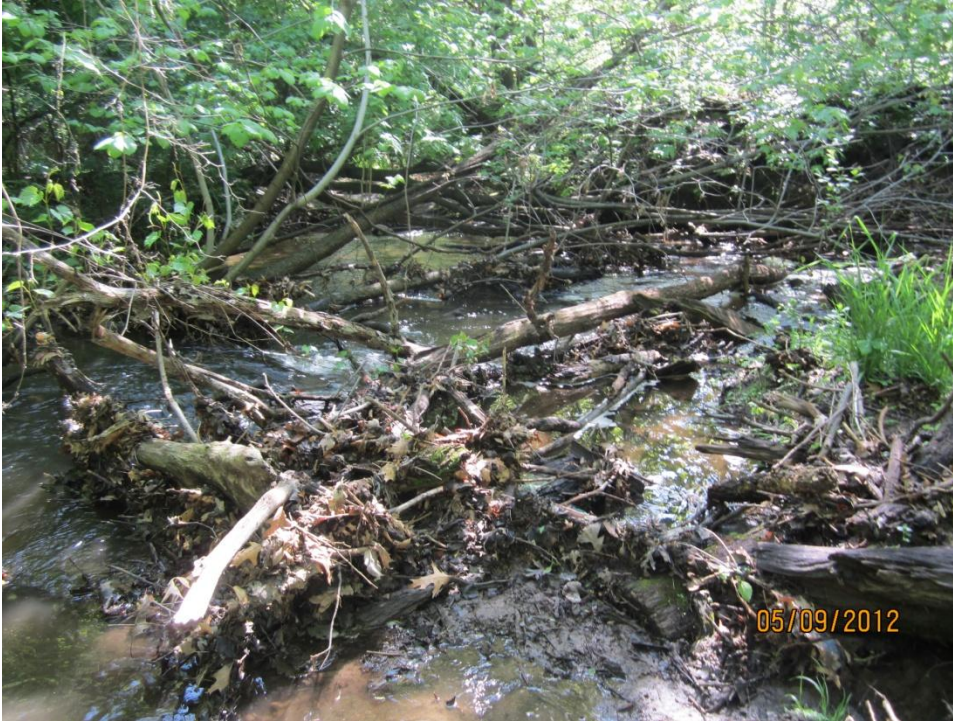
Large obstruction in lower portion of creek.  
Water is being diverted into bank, causing erosion.

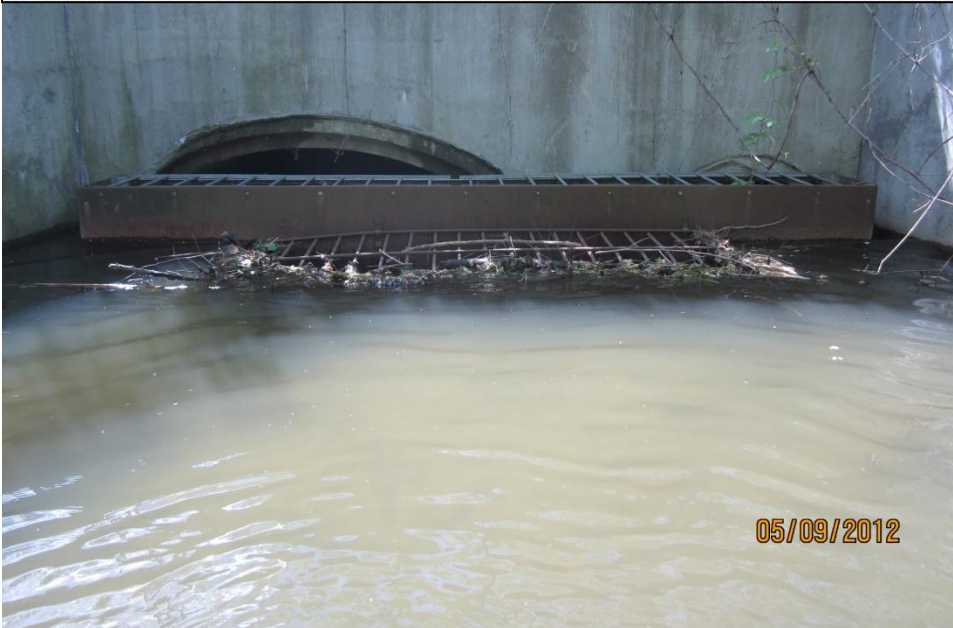
Obstructed trash rack on upstream end of East River Road.  
Temporarily relieved 5-9-2012.

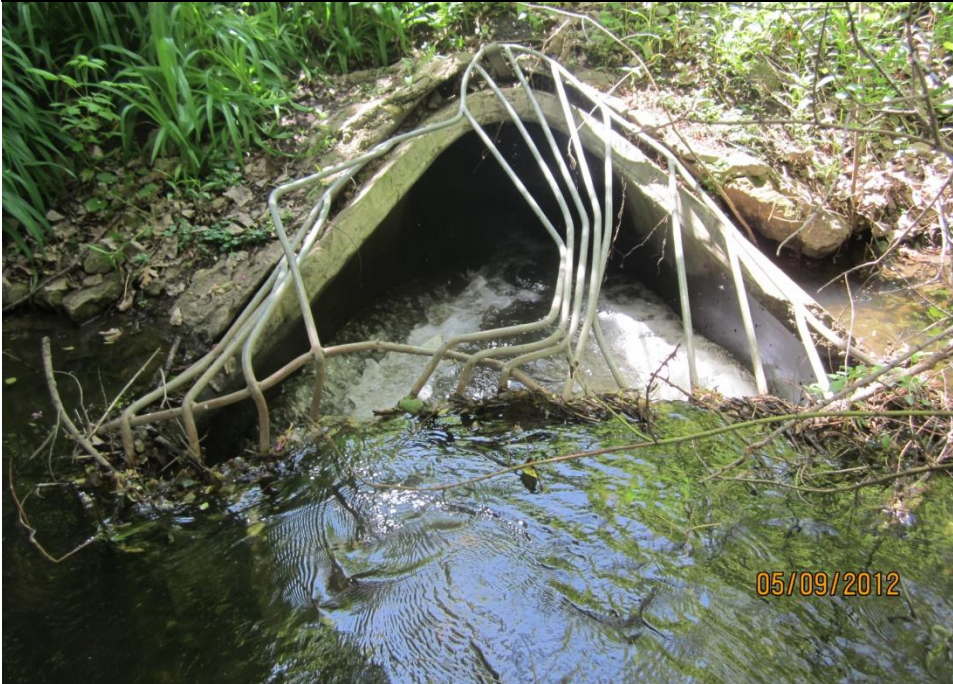
**Obstructed trash rack on upstream end of Norway Street.  
Temporarily relieved 5-9-2012.**

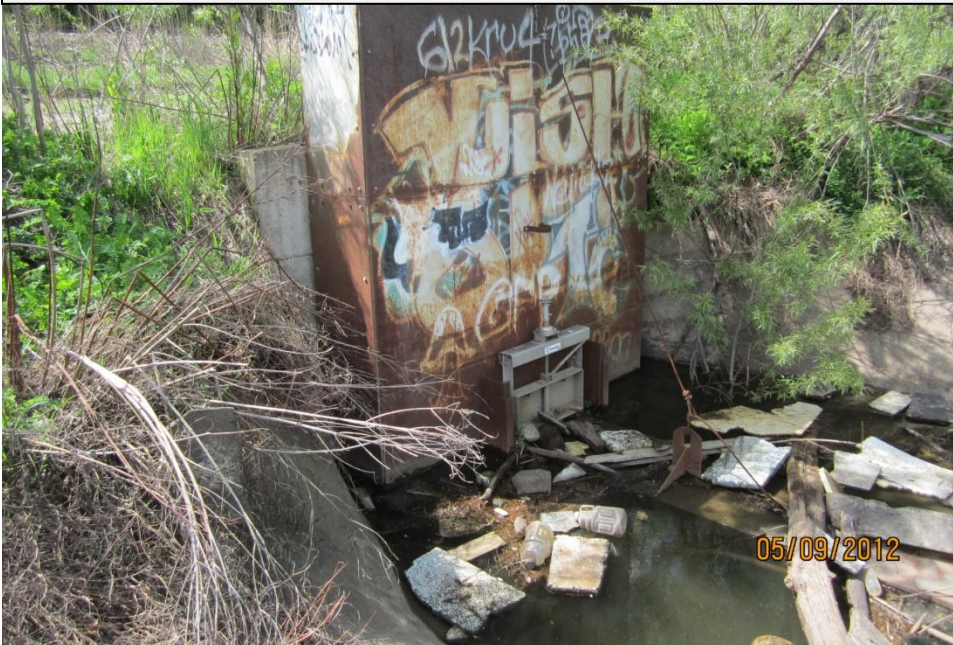
**Structure on upstream end of Rail Road.  
Accumulation of debris.**

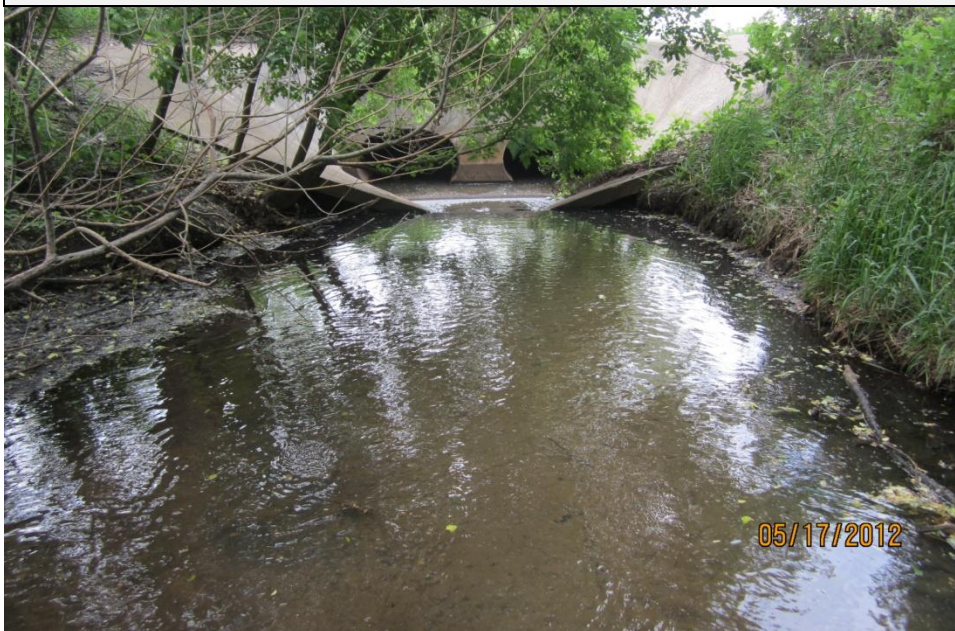
**Fish barrier on upstream end of Evergreen Blvd.**

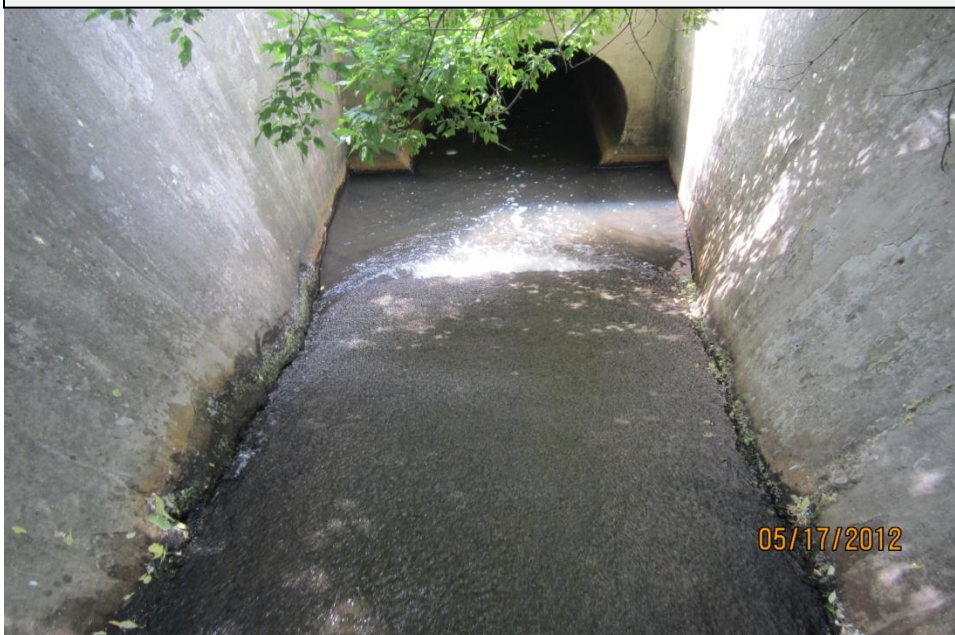
**Fish barrier on upstream end of Holly Street NW.**

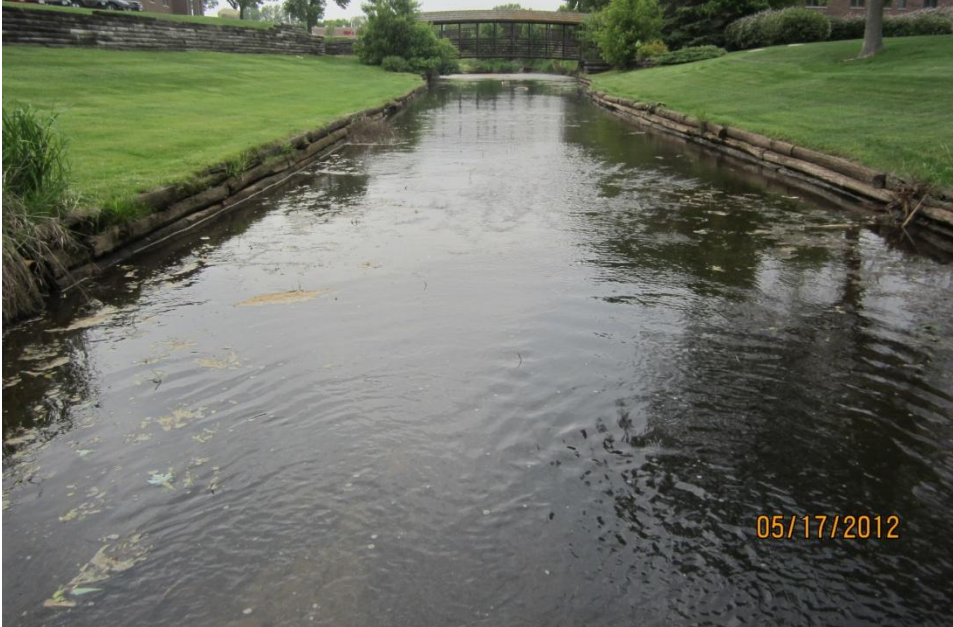
**Pond created by wood weir upstream of Coon Rapids Blvd.  
Accumulation of animal feces (primarily goose).**

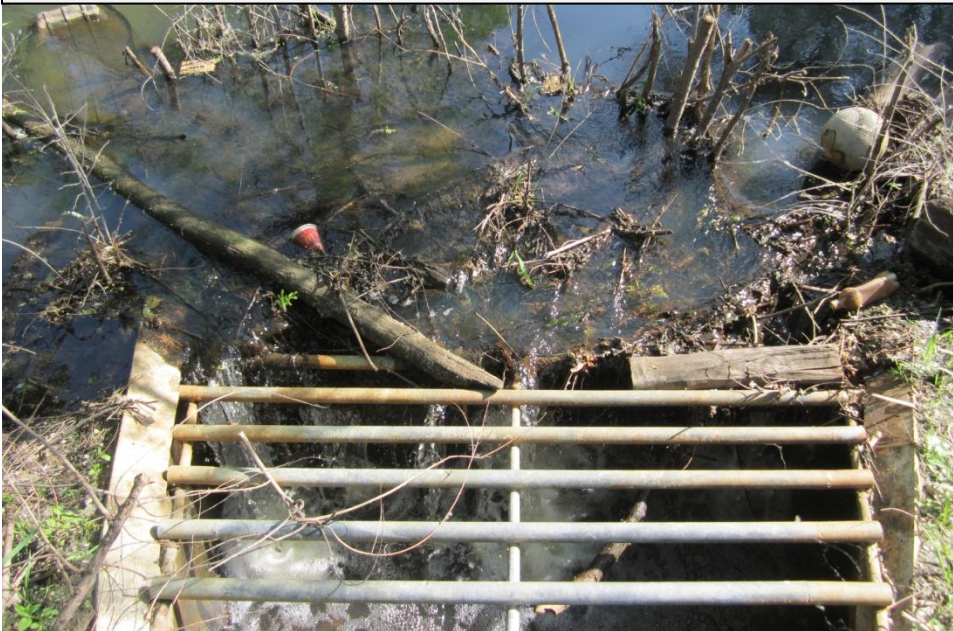
**Obstructed trash rack on upstream end of 96<sup>th</sup> Lane NE.  
Temporarily relieved 5-18-2012.**
