COON CREEK WATERSHED DISTRICT

Ditch 20 Inspection Report

Jason Hilst
Operations & Maintenance Inspector
January 22, 2024

Ditch 54 Inspection Report

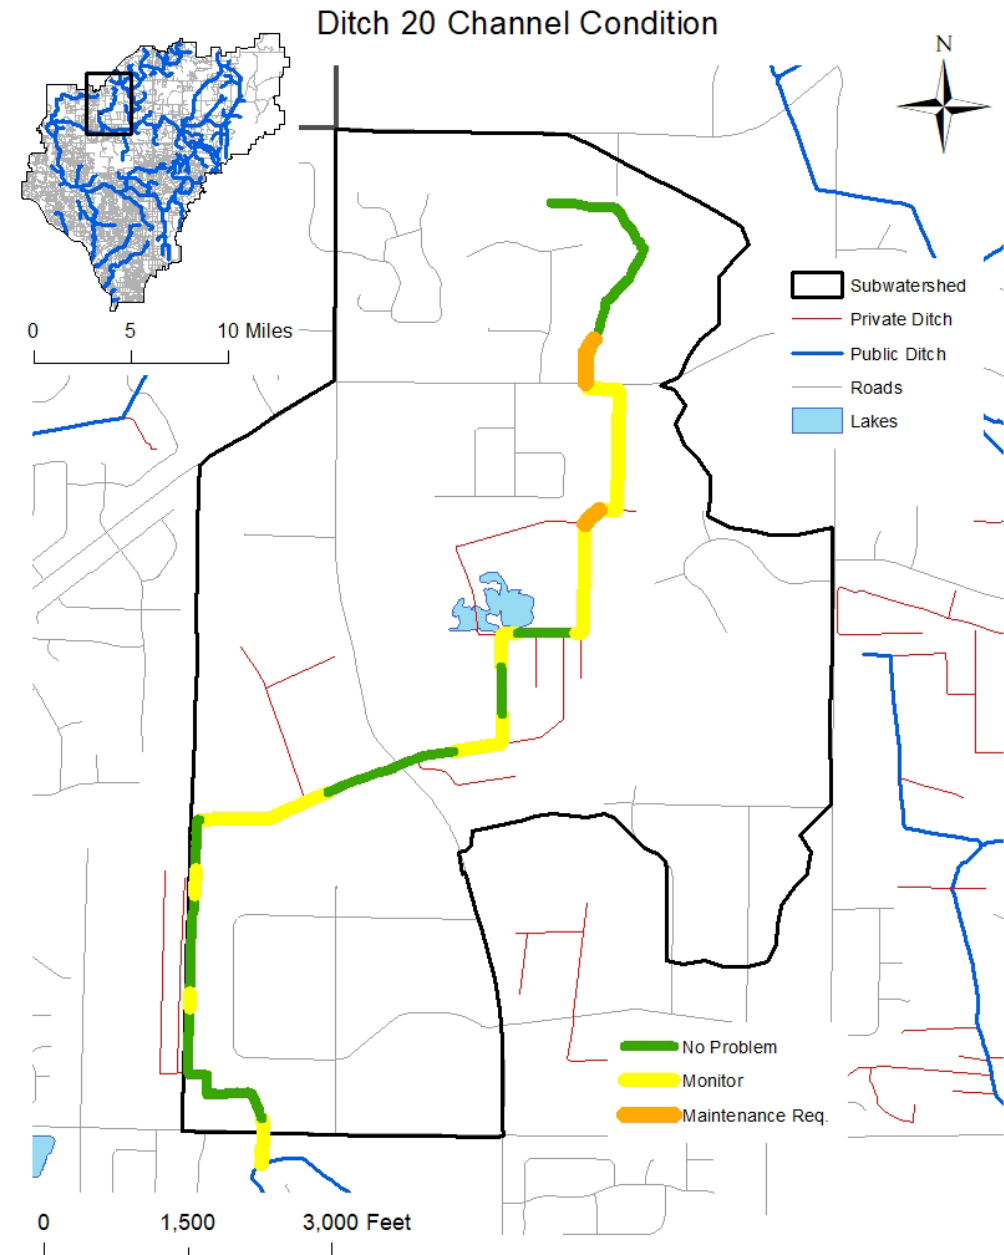
Channel Condition

Overall Condition: Fair/Good

Fair/Good throughout

Fair/Poor two small sections

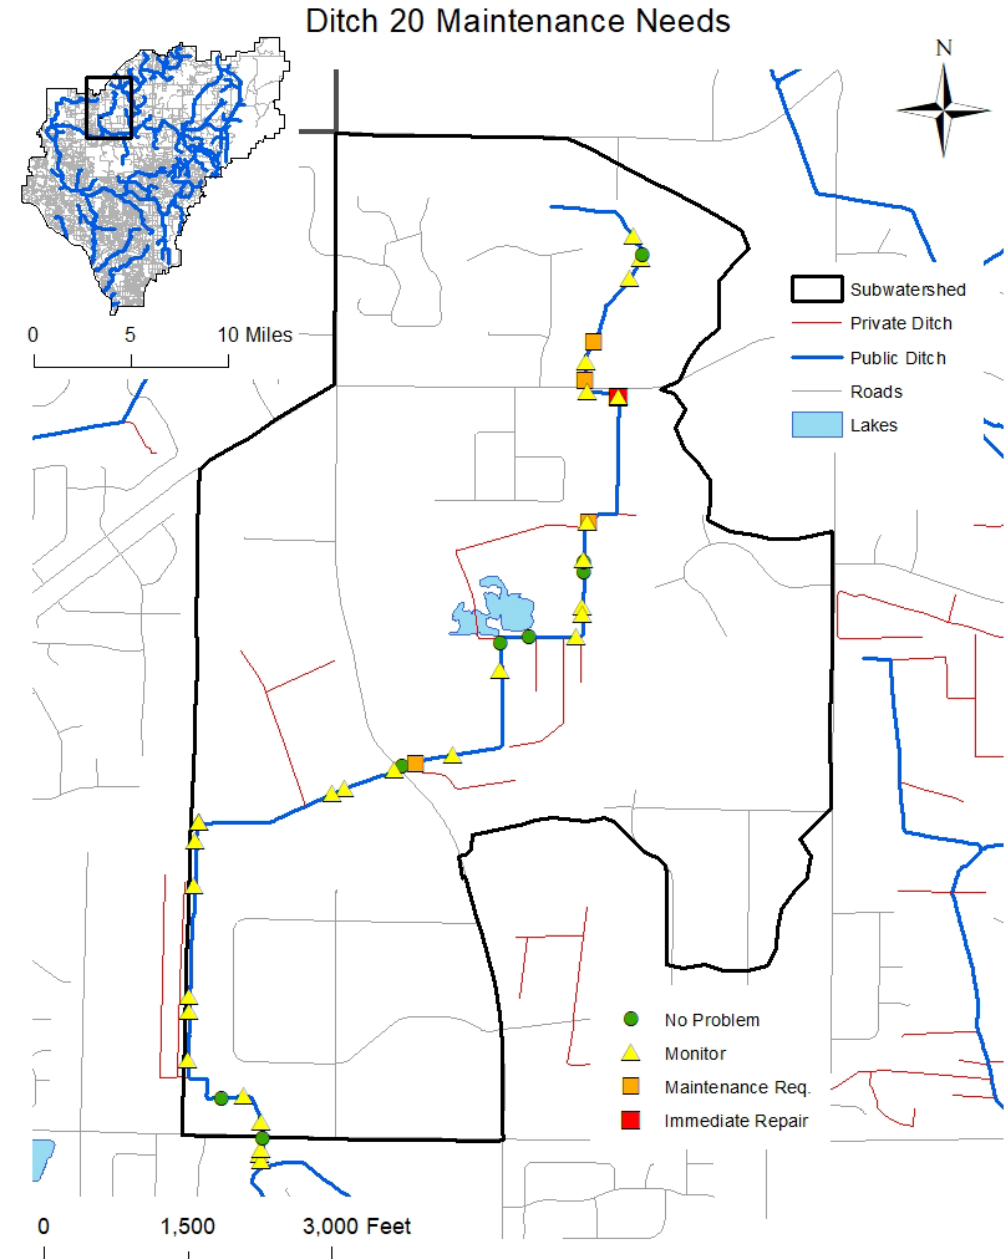
Inspection Results

Need	Timeframe	# Sites	Estimated Cost
Immediate	<1 year	1	\$0
Projected	1-5 years	4	\$9,000
Potential	5+ years	37	\$107,660
TOTAL		42	\$116,660

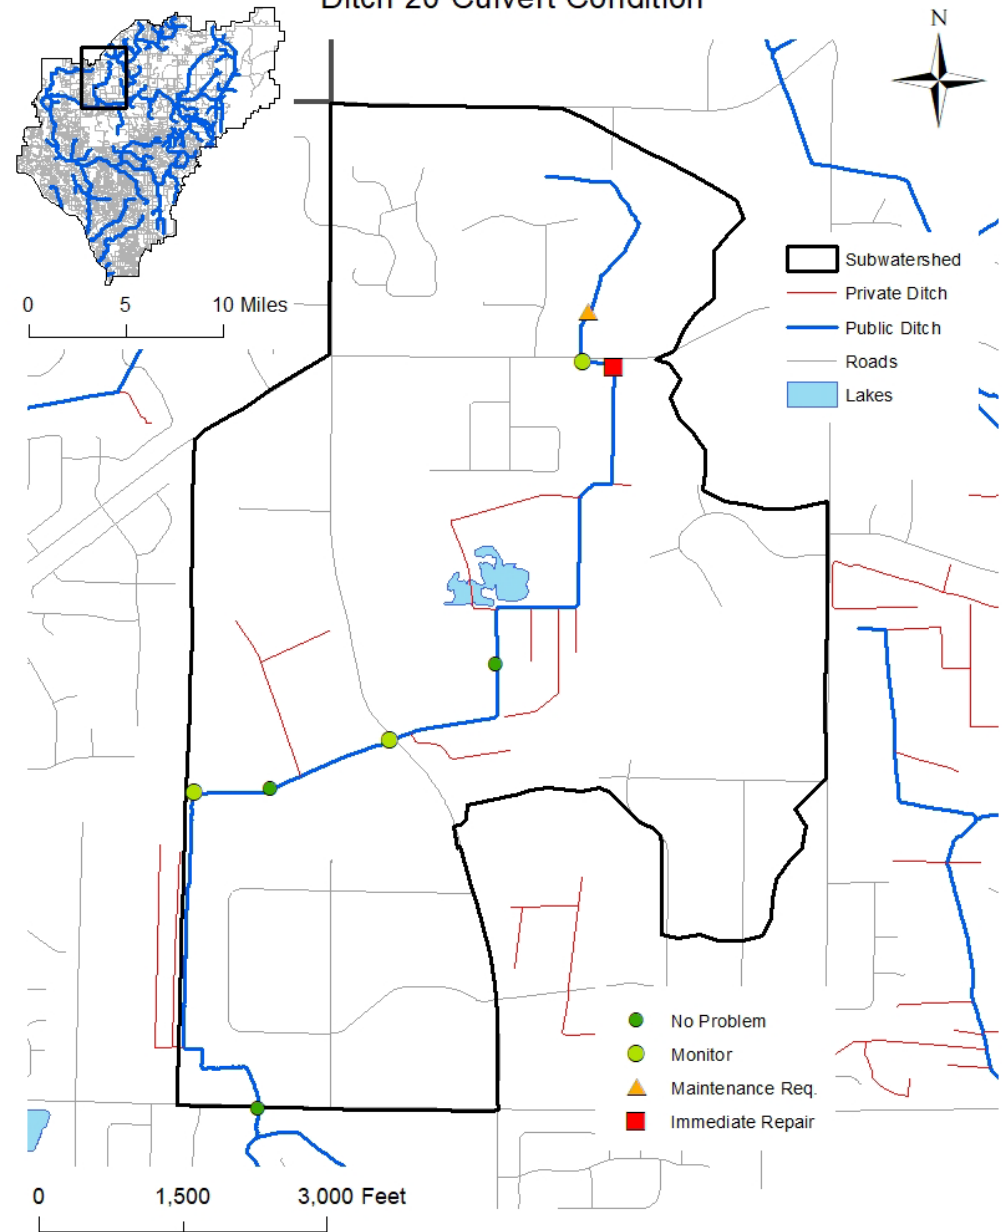
Ditch 20 Culvert Condition

There is only one immediate maintenance concern (buried culvert)

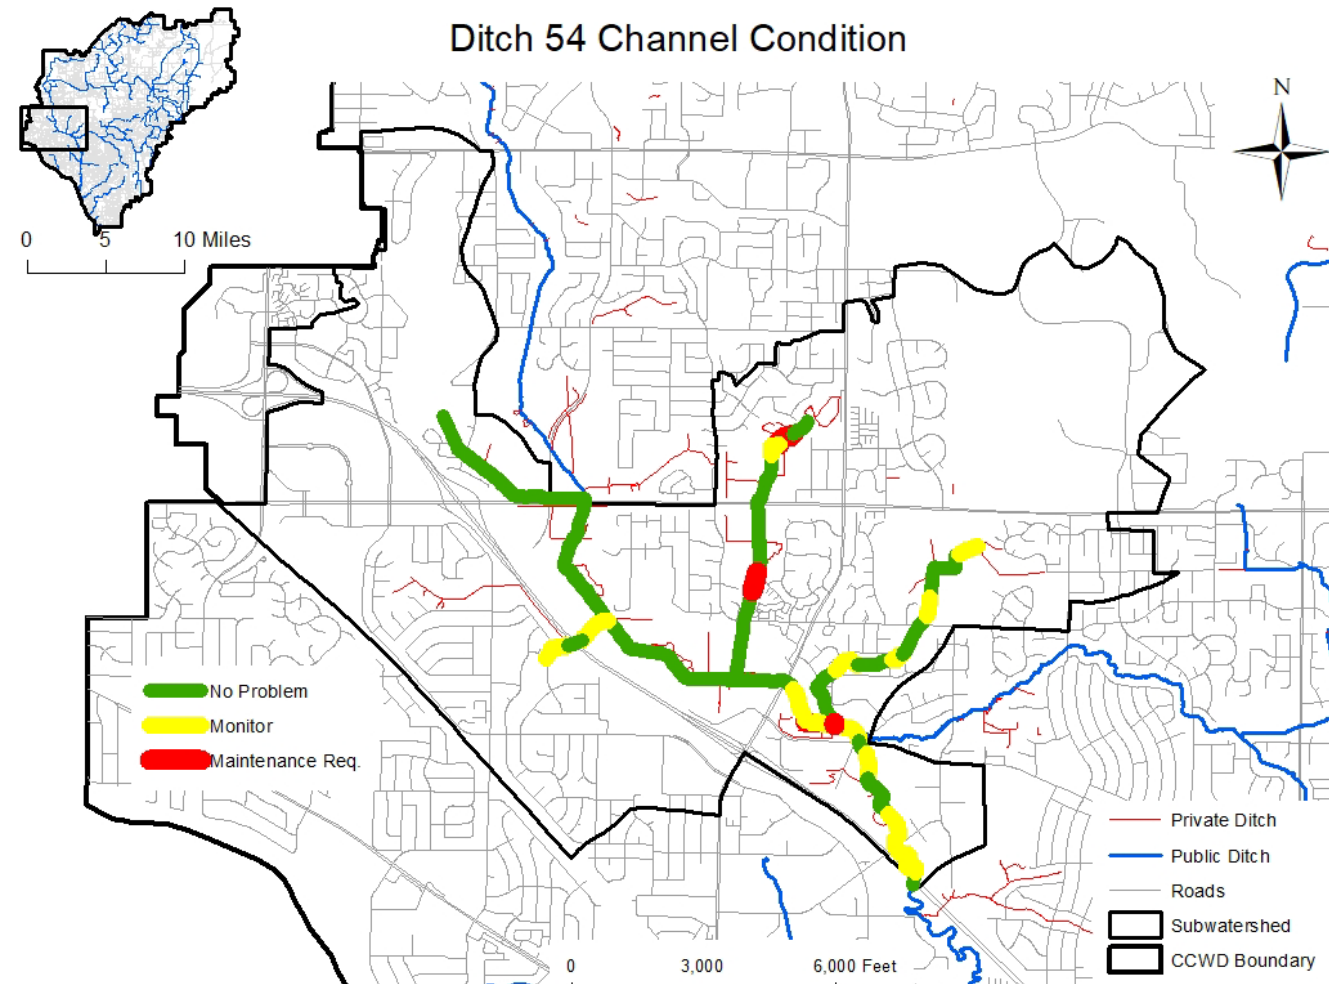
Channel Condition

Overall Condition: Fair/Good
Good/Fair throughout
Fair/Poor several small sections

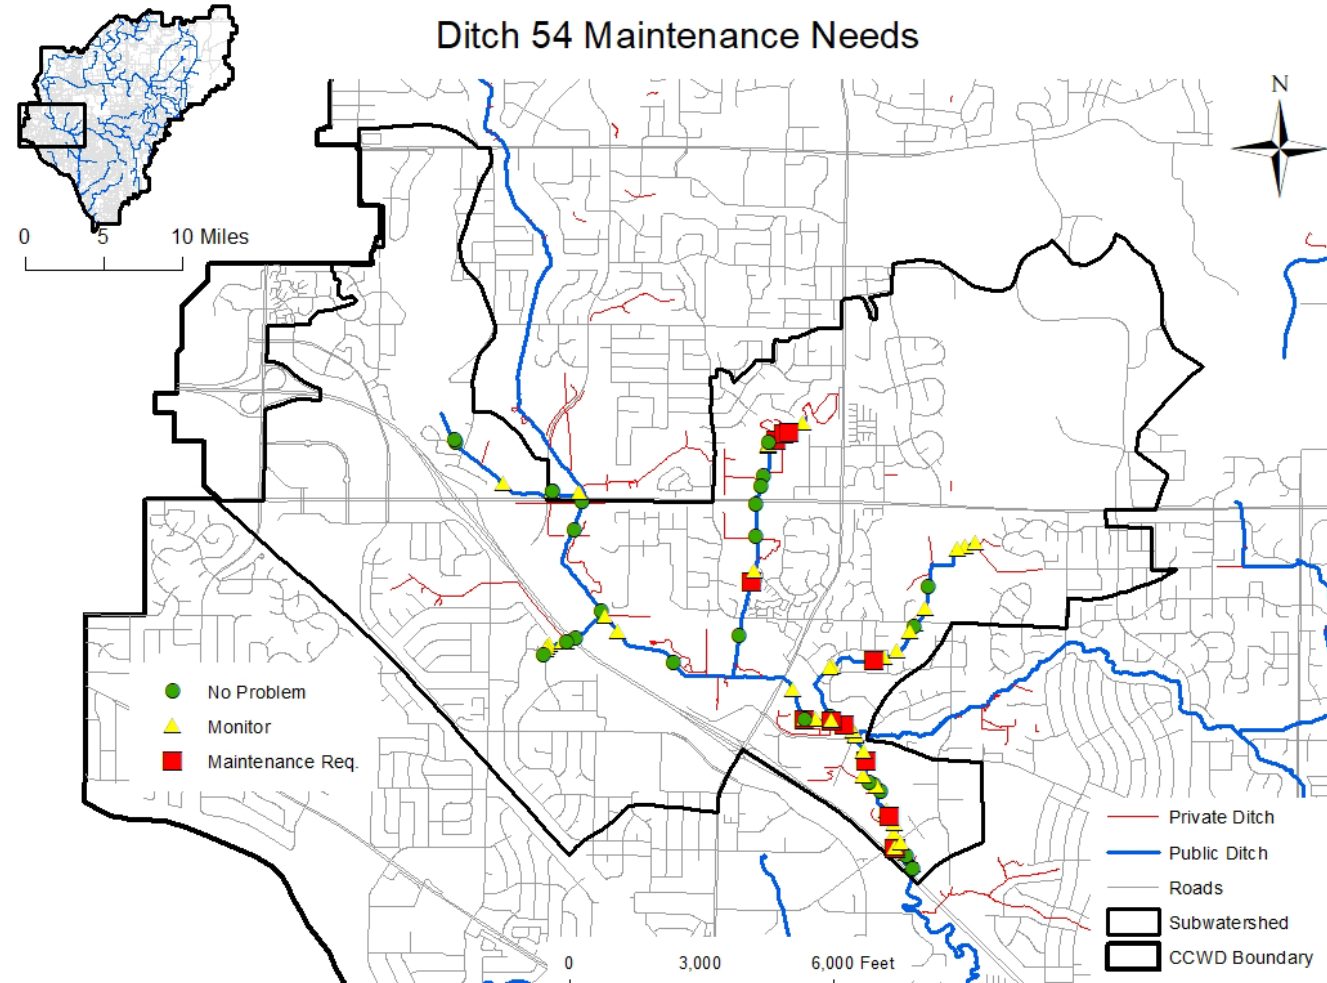
Inspection Results

Need	Timeframe	# Sites	Estimated Cost
Immediate	<1 year	0	\$0
Projected	1-5 years	14	\$30,984
Potential	5+ years	82	\$662,845
TOTAL		96	\$693,828
