Early-Spring Curlyleaf Pondweed Delineation

Crooked Lake (# 02-0084) Anoka County, MN

Surveyed April 30, 2019

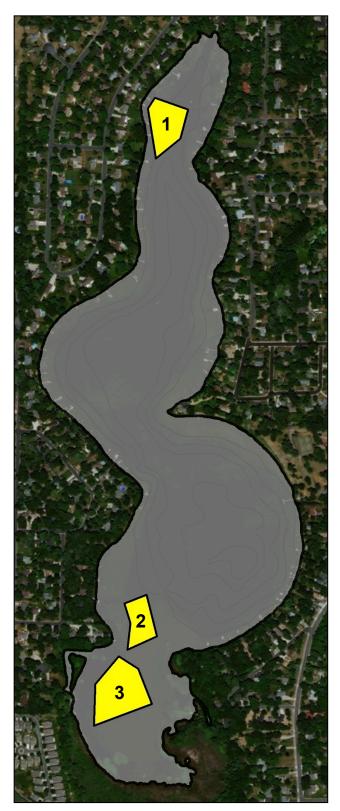
2019 Early-Spring Delineation of Curlyleaf Pondweed Crooked Lake (# 02-0084)

Potential Management Plots

Plot	Area (acres)	Mean Depth (ft)	Mean EWM Density (1-3)
1	1.9	4.3	2.0
2	1.4	3.0	1.7
3	3.1	3.1	2.3

Total 6.4

Surveyed: April 30, 2019 Methods: Visual, Sonar, Rake Surveyor: JA Johnson
