Lower Sand Creek Corridor Restoration

Public Meeting

Coon Creek Watershed District City of Coon Rapids

May 22nd, 2018

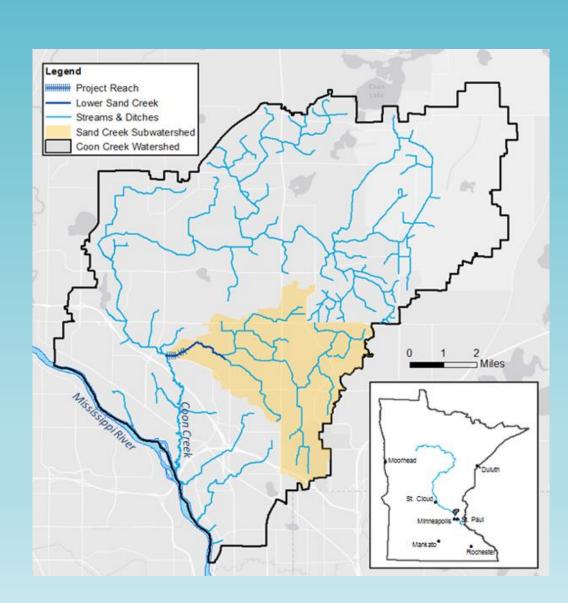
Sand Creek Drainage Area

Size: ~16 mi²

Suburban land use

Upstream area ditched for agriculture & now serves as stormwater conveyance system.

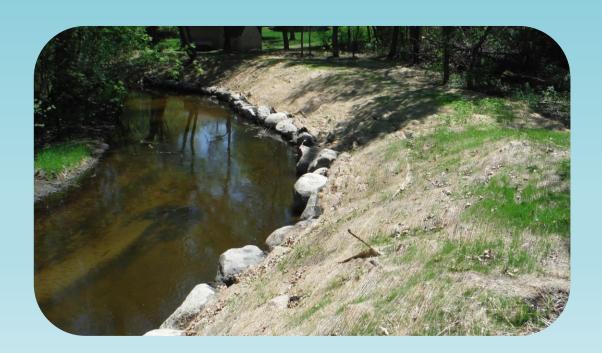
Vegetated Rock Riprap (~1100 LF)

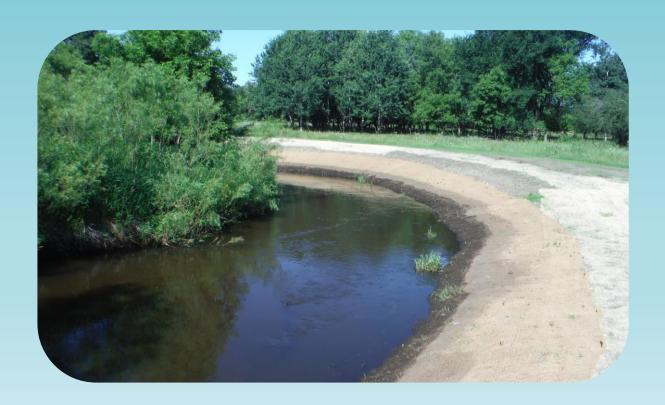
Re-grading & seeding (~1500 LF)

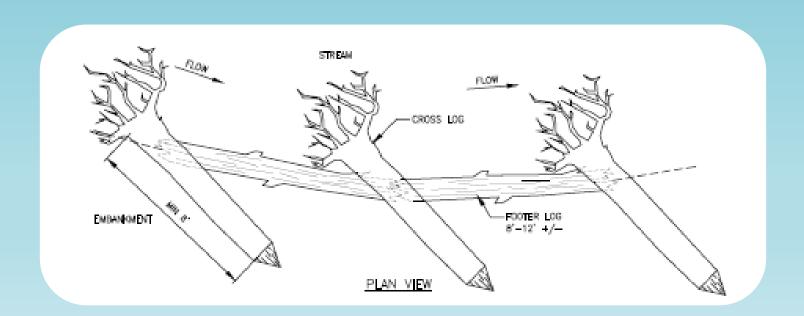
Woody materials: log toes, root wads, revetments (~1600 LF)

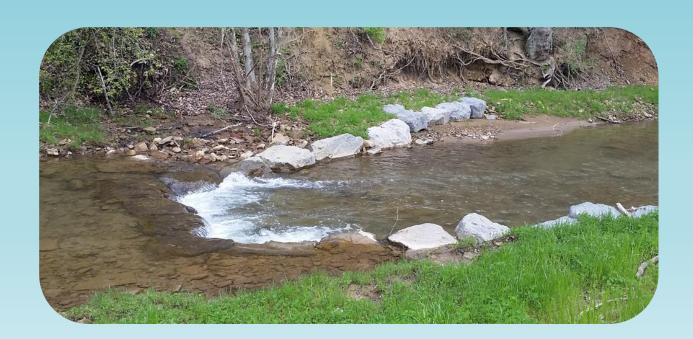
6 cross vanes to create riffles & pools

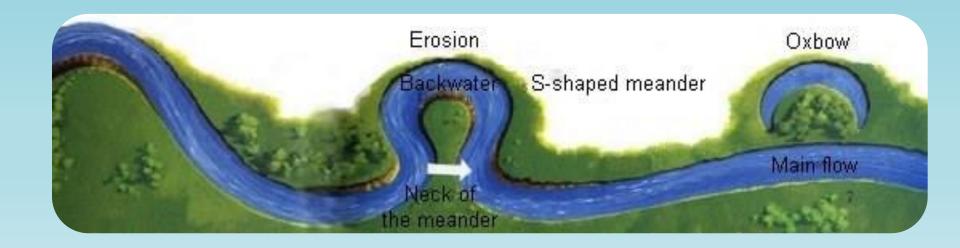
Excavating 3 backwater pools

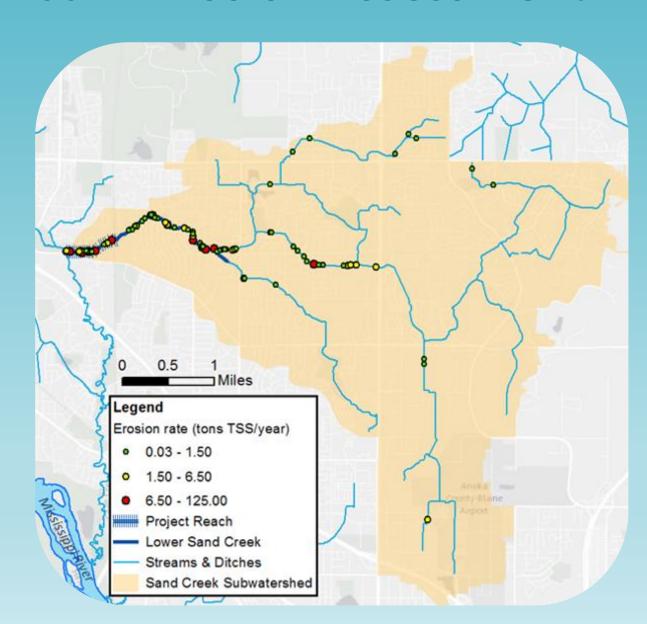
2015 Streambank Erosion Assessment

Sand Creek Subwatershed:

83 sites 931 tons/yr

Project Reach:

16 sites 372 tons/yr

Erosion hotspot!
