Ham Lake Comprehensive Lake Management Plan 2018-2022

Prepared by the Coon Creek Watershed District
November 2017

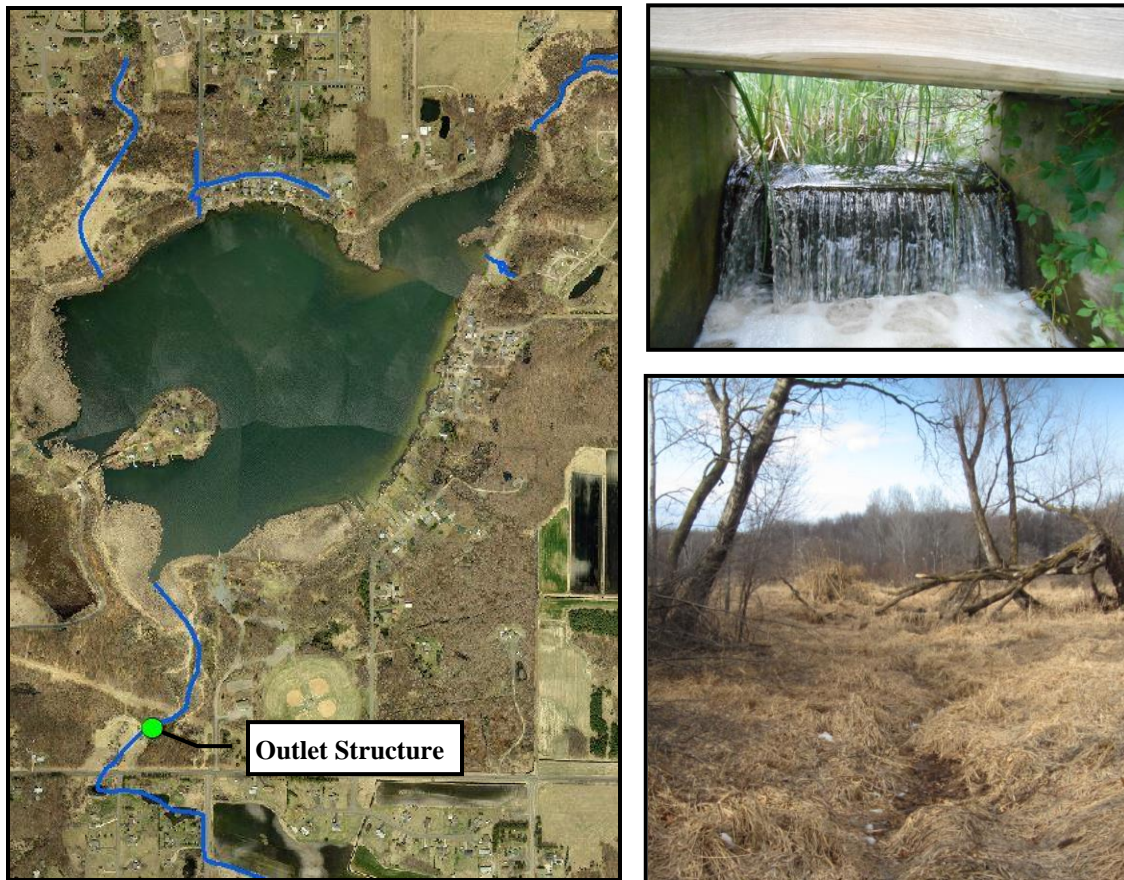
Figure 4. Location of the Ham Lake outlet and photographs of the box culvert during wet conditions (upper right) and the channel looking upstream of the outlet structure during dry conditions (lower right).

Ham Lake has one outlet located at the southern tip of the lake (Figure 4). Water flows through an expansive wetland area, over a concrete weir set at an elevation of 896.7 ft, through a box culvert, and eventually discharges to Coon Creek. The outlet structure was constructed in 1953 by the MN DNR and is inspected annually by the Coon Creek Watershed District.

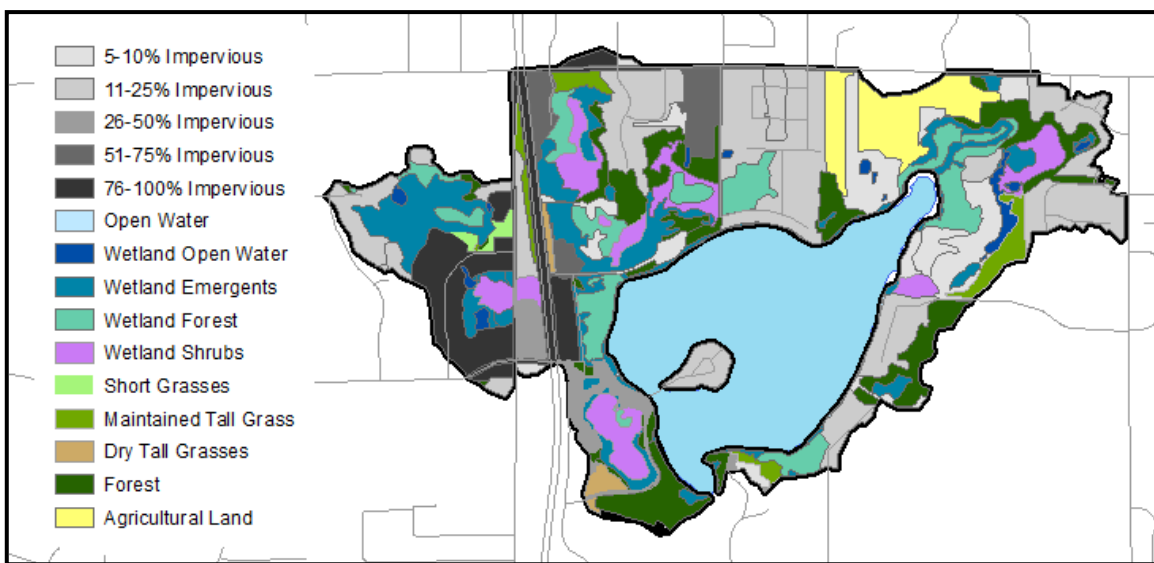
Figure 6. Land cover in the Ham Lake lakeshed

The land cover surrounding Ham Lake is mostly natural, with both forested areas and expansive wetlands (Figure 6). In the developed areas, land cover is generally less than 25% impervious, except for along the Highway 65 corridor.

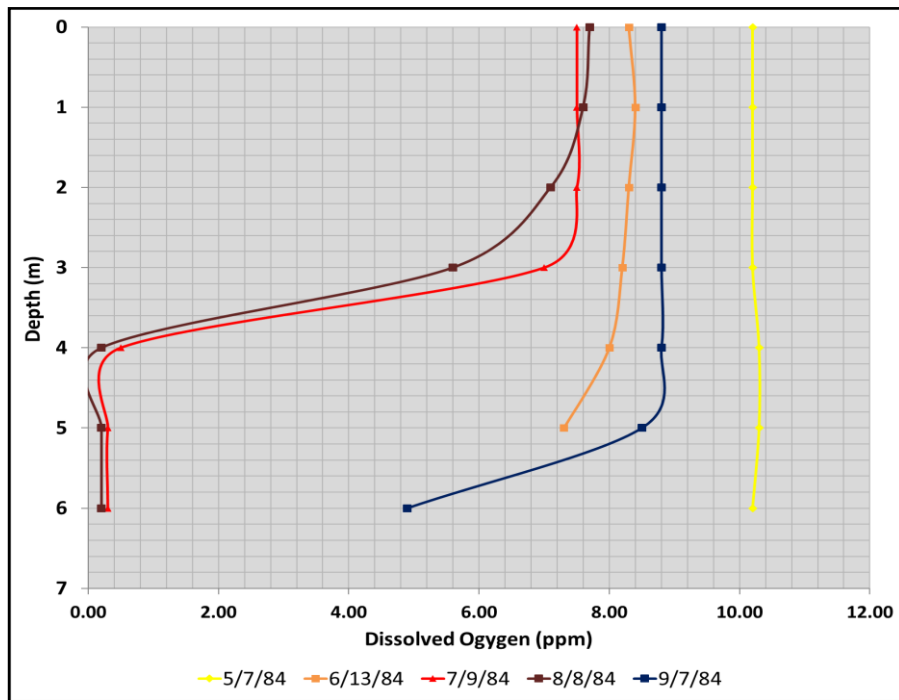
Figure 11. Monthly dissolved oxygen profiles measured at the deepest point in Ham Lake from May through September of 1984 (MPCA).

The presence and extent of lake stratification is observed by taking measurements of temperature and/or dissolved oxygen at various depths throughout the year. There is very limited data available to assess stratification in Ham Lake. No temperature profiles have been reported, but monthly oxygen profiles were measured in Ham Lake throughout the open water season of 1984. Despite being a shallow lake, Ham Lake does have a 22-foot deep hole which likely leads to stratification in most years. In 1984, there was evidence of stratification from early July through August (Figure 11). The water column dissolved oxygen levels were homogenous in May and into Mid-June (yellow and orange profiles), but the waters deeper than roughly 4 meters were depleted of oxygen in July and August (red profiles), and there was evidence of lake mixing by early September (violet profile).

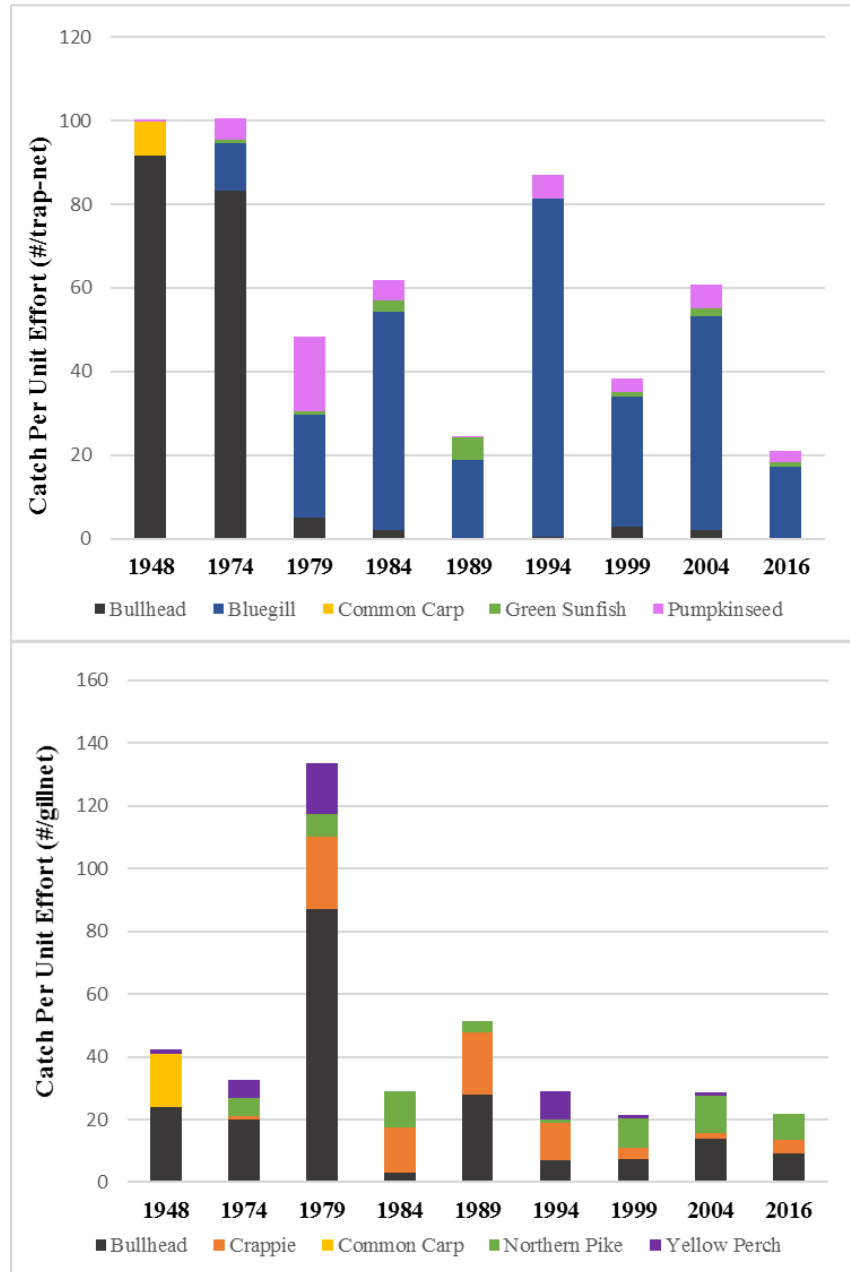
Figure 18. Catch per unit effort (# per net) of the 5 most commonly sampled fish species during standardized MN DNR trap-net surveys (upper panel) and gill net surveys (lower panel) from 1948 through 2016.

Catch rates of 5 most commonly sampled species are variable between years and gear types (trap-nets versus gill nets), but are generally stable since the 1980s (Figure 18). Based on the most recent survey in 2016, Ham Lake supports above average numbers of bluegill sunfish, pumpkinseed sunfish, largemouth bass, and northern pike compared to other Class 38 lakes. The average weight of largemouth bass and northern pike is also above average, but below average for sunfish. The abundance of crappie and yellow perch is below average. It should be noted that largemouth bass are not well-represented by standard DNR survey methods, but supplemental electrofishing surveys conducted in 1994 and 1999 indicate very high catch rates of largemouth bass (68 & 81 bass per hour, respectively).

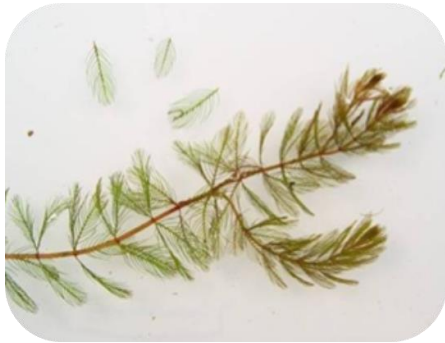
Hybrid/Eurasian watermilfoil

- Nuisance growth/expansion of the aquatic invasive species that are already established in Ham Lake: hybrid/Eurasian watermilfoil and curlyleaf pondweed
- The possibility for new invaders such as zebra mussels or starry stonewort to enter and establish in Ham Lake

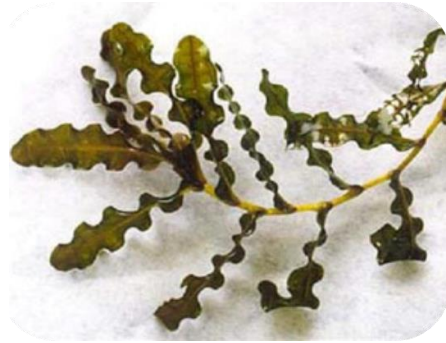
Curlyleaf pondweed

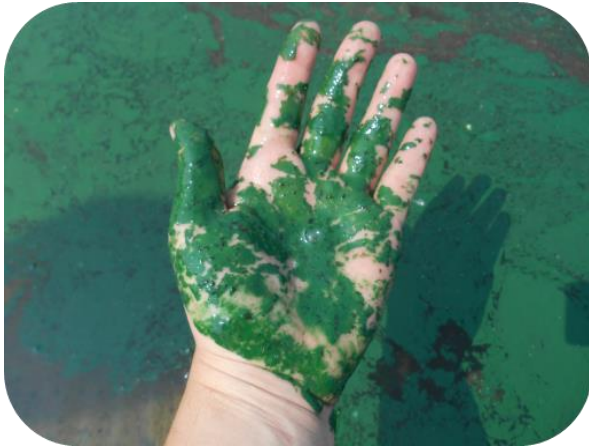
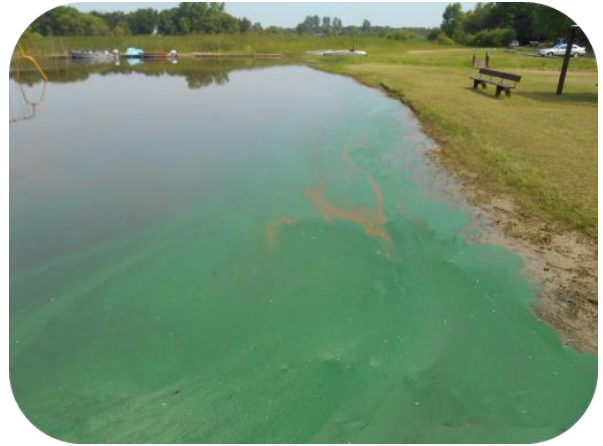
A blue-green algae bloom observed at the Ham Lake Campground in August 2014

- The occurrence of blue-green algae (cyanobacteria) blooms & associated safety risks
- Possible pollution from failing septic systems
