Middle Sand Creek Corridor Restoration

Public Meeting

Coon Creek Watershed District City of Coon Rapids

September 24th, 2019

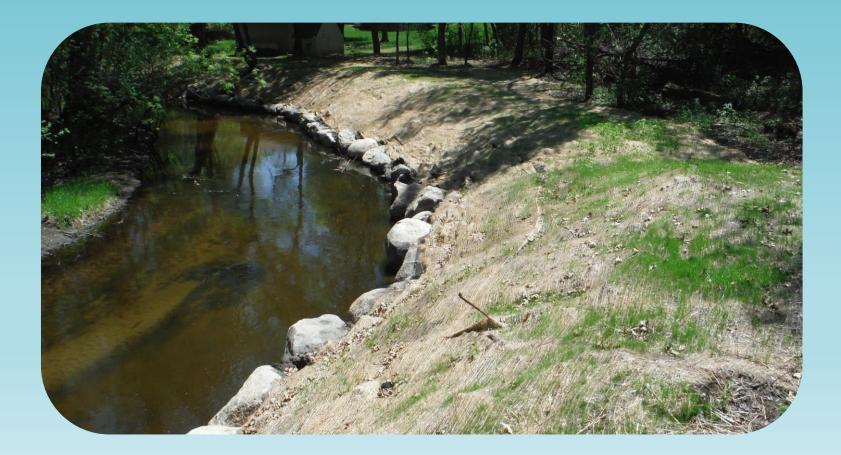
Stabilize eroding banks using 3 methods:

Vegetated Rock Riprap

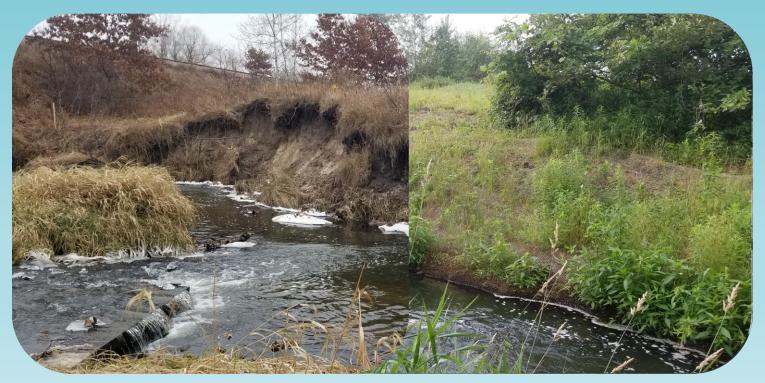
Lower Sand Creek Example

Stabilize eroding banks using 3 methods:

Vegetated Rock Riprap

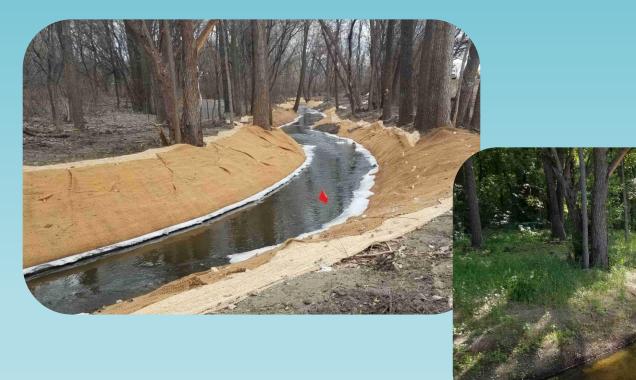
Lower Sand Creek Example

1. Reduce excess sediment/phosphorus Stabilize eroding banks using 3 methods:

Vegetated Rock Riprap

Re-grading & seeding

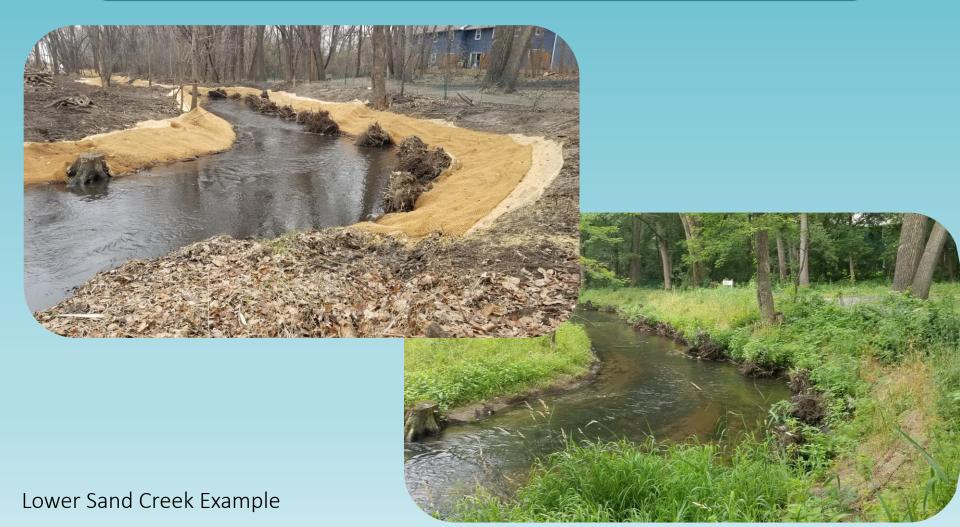
Woody materials: log toes, root wads, toe wood

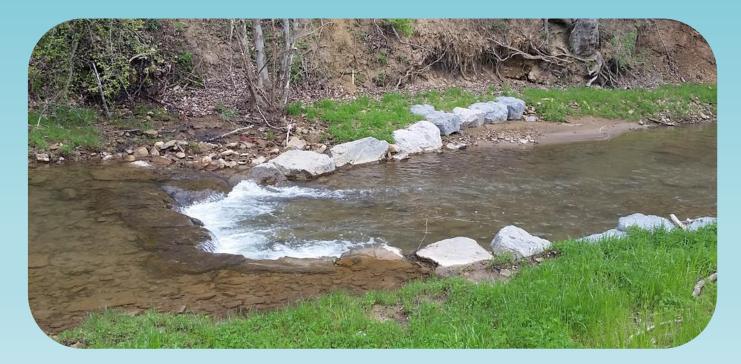
Incorporating wood in bank stabilization practices

Adding in-stream structures: cross vanes, rock riffles, J-hooks

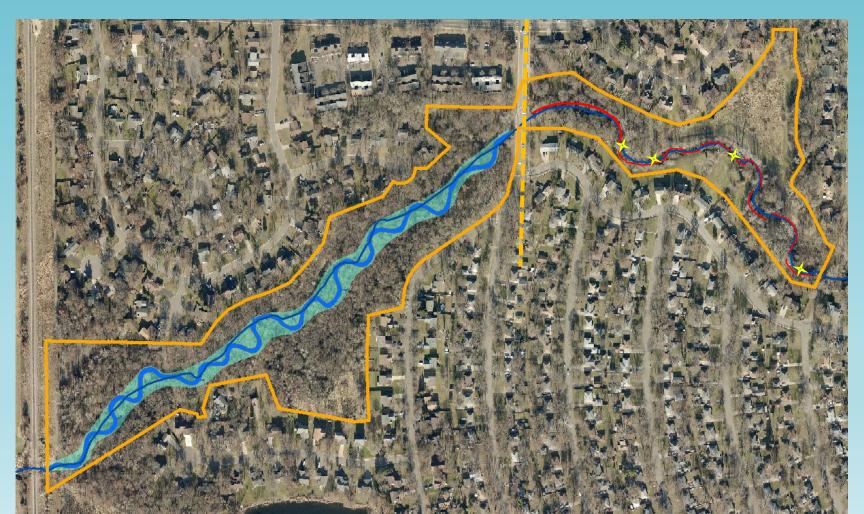
- <u>Upstream reach</u>: stabilize banks in place + add in-channel habitat elements
- <u>Downstream reach</u>: Natural channel design
