# Lower Sand Creek Corridor Restoration Project

FY17 319 Grant #134304: Final Report

## Coon Creek Watershed District

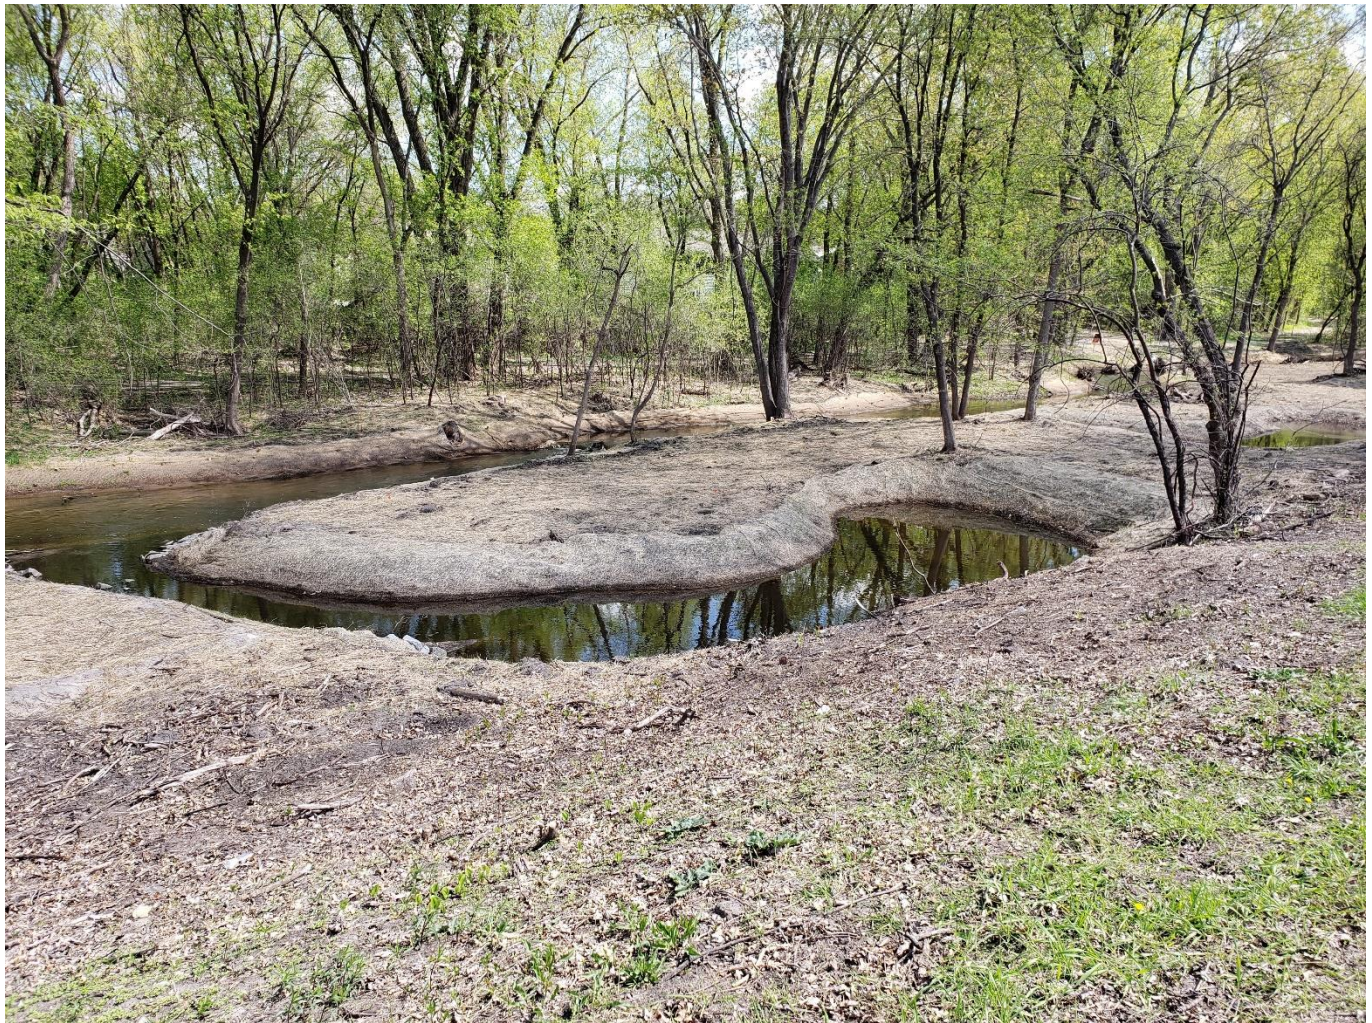
A former oxbow was excavated and reconnected with the channel as a backwater habitat

This 2018-19 project stabilized 2900 LF of actively eroding banks and 5 gullies, established vegetative buffers along ½ mile of stream, and also improved in-stream and riparian habitat. Specifically, eroding banks were stabilized with vegetated riprap, root wads with log toe, or via regrading and vegetating using native species. The dense tree canopy along the project corridor was opened up by thinning trees and clearing invasive buckthorn which allowed for the native plantings to flourish, establishing a contiguous vegetated buffer to improve bank stability and filter overland runoff. In-stream habitat was improved by incorporating woody debris in stabilization practices, installing boulder and log vanes to halt channel incision and create riffle-pool sequences, and by excavating 5 backwater pools in former oxbows to reconnect the adjacent floodplain and add lentic habitats.

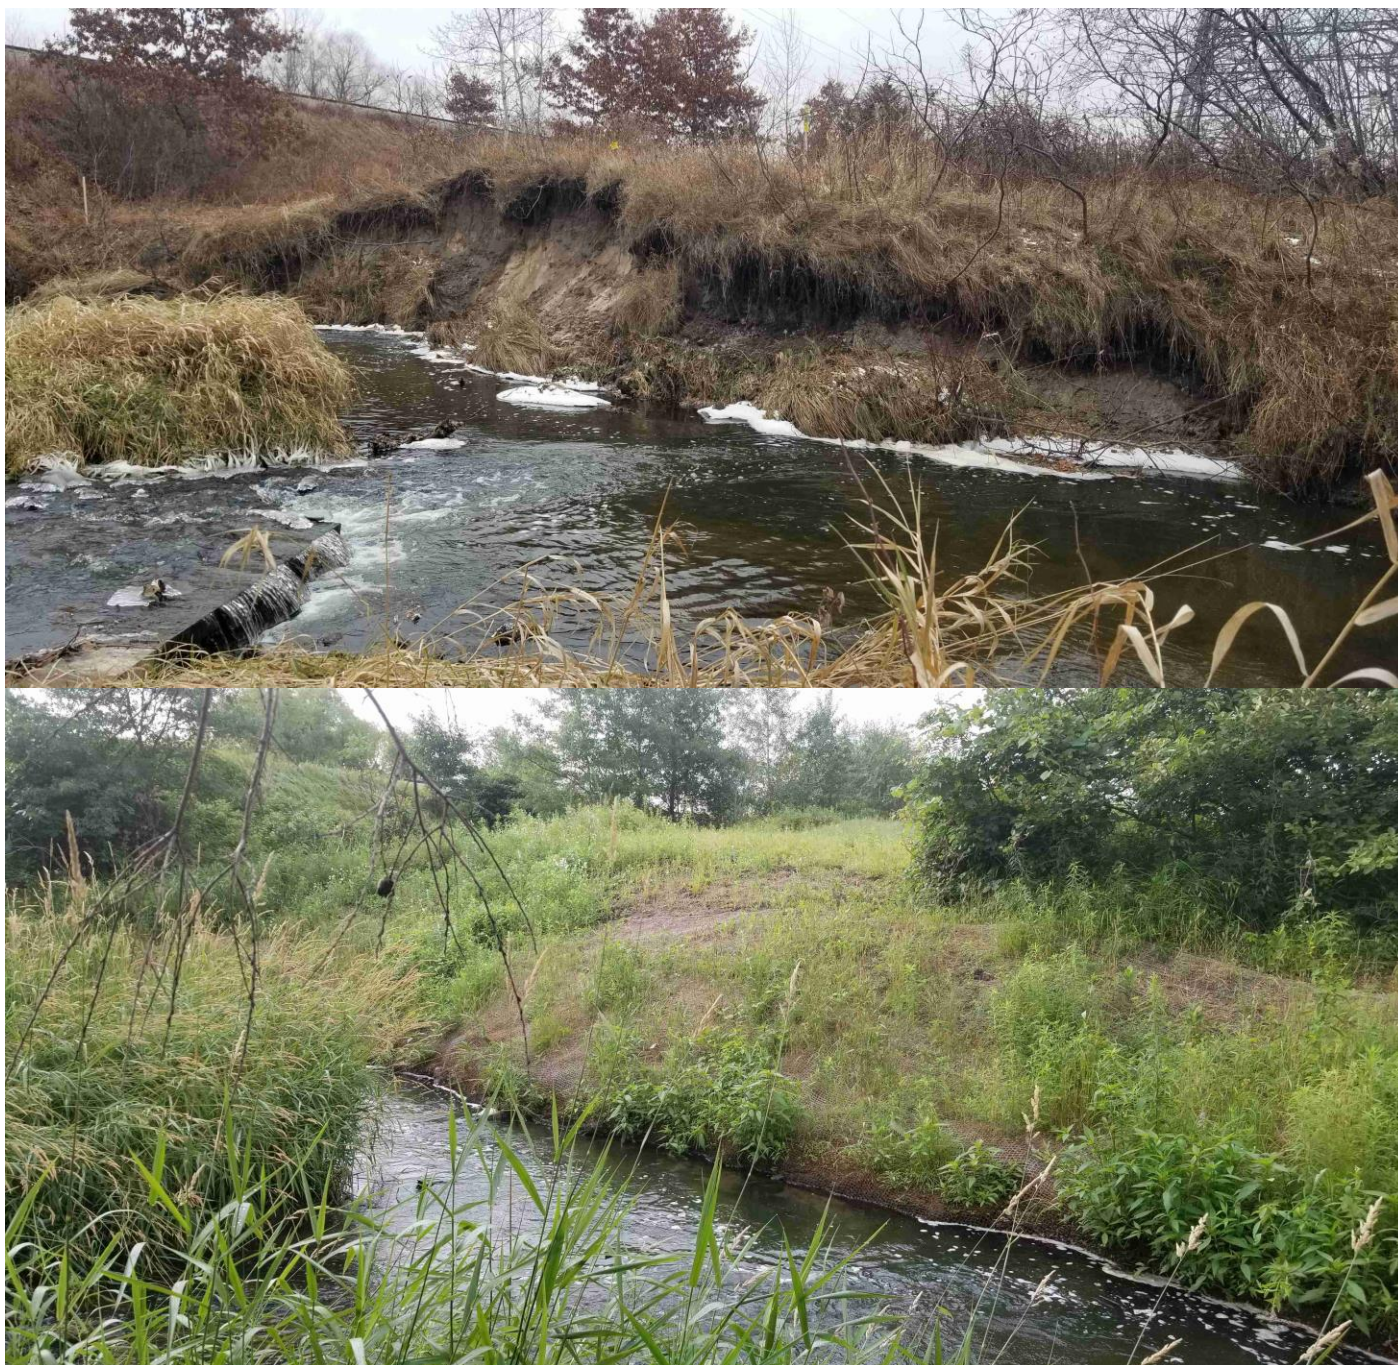
An eroded bank before and after stabilization with vegetated riprap

The Lower Sand Creek Corridor Restoration project stabilized all 16 actively eroding banks (2900 LF) and 5 adjacent gullies, established vegetative buffers along ½ mile of stream, and also improved in-stream and riparian habitat. Specifically, eroding banks were stabilized with vegetated riprap, root wads with log toe, or via regrading and vegetating using native seed mixes, live stakes, and native trees. The dense tree canopy along the project corridor was opened by thinning trees and clearing invasive buckthorn which allowed increased sunlight penetration for the native plantings to flourish, establishing a contiguous vegetated buffer to improve bank stability and filter overland runoff. In-stream habitat was improved by incorporating woody debris in the bank stabilization practices, installing 6 boulder cross vanes and log vanes to halt channel incision and create riffle-pool sequences, and by excavating 5 backwater pools in former oxbows to reconnect the adjacent floodplain and add lentic habitats. Combined, these BMPs reduced annual sediment and phosphorus loads by an estimated 372 tons and 316 pounds, respectively. Furthermore, these practices also reduced soil-bound bacteria loading to Sand Creek and downstream Coon Creek. Future planned water quality monitoring and biomonitoring (2020 assessment by MPCA) will verify these pollutant load reductions and biotic improvements towards eventual delisting of Sand Creek by 2045. Implementation of this project in 2018-19 constitutes the first phase of ongoing stream corridor restoration work to address bank erosion and poor in-stream habitat. Phase 2, the Middle Sand Creek Corridor Restoration project, is currently underway and is on schedule for completion in 2021. Prior to this work, several water quality improvement projects were completed in the drainage area including construction of a new ¼-ac stormwater pond, 25 rain gardens, and modifications of outlet structures to increase storage volume and reduce peak flows. Additional work in the watershed is required to address phosphorus and *E. coli* loading attributable to urban stormwater inputs.

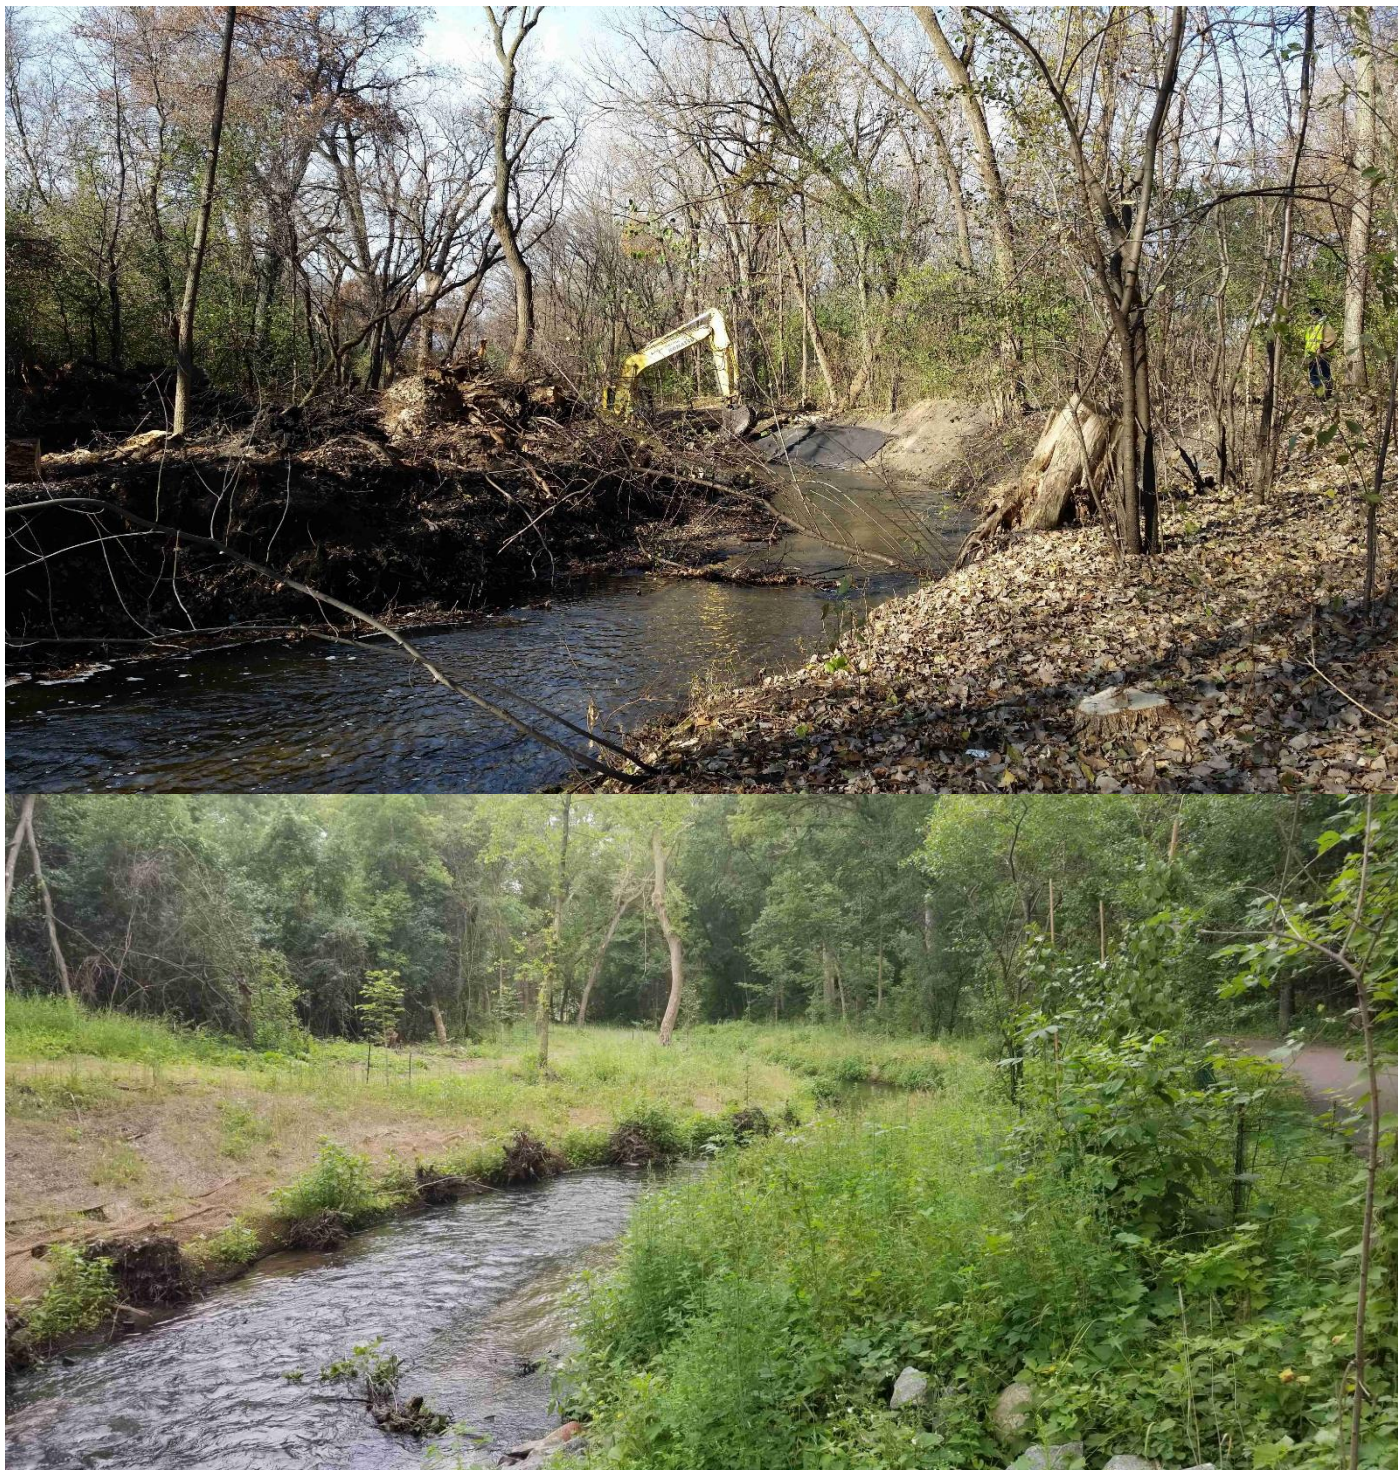
An eroded bank before and after stabilization with log toe and root wads

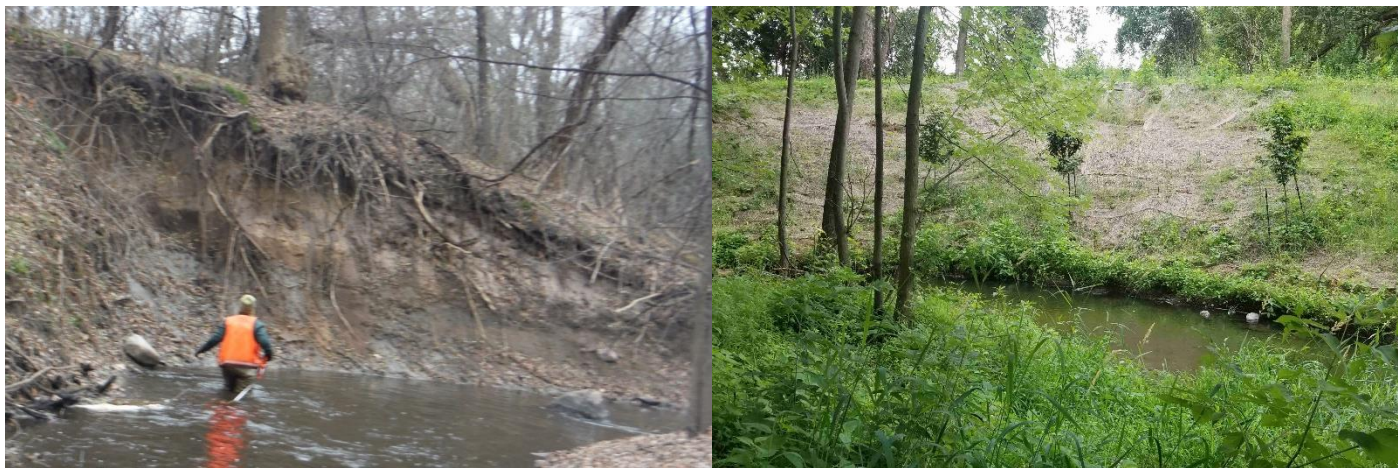
A severely eroded bank before and after stabilization via regrading and revegetating
