# Pleasure Creek

**Excerpted from  
Pleasure Creek Inspection Report**

**Coon Creek Watershed District  
June 1, 2012**

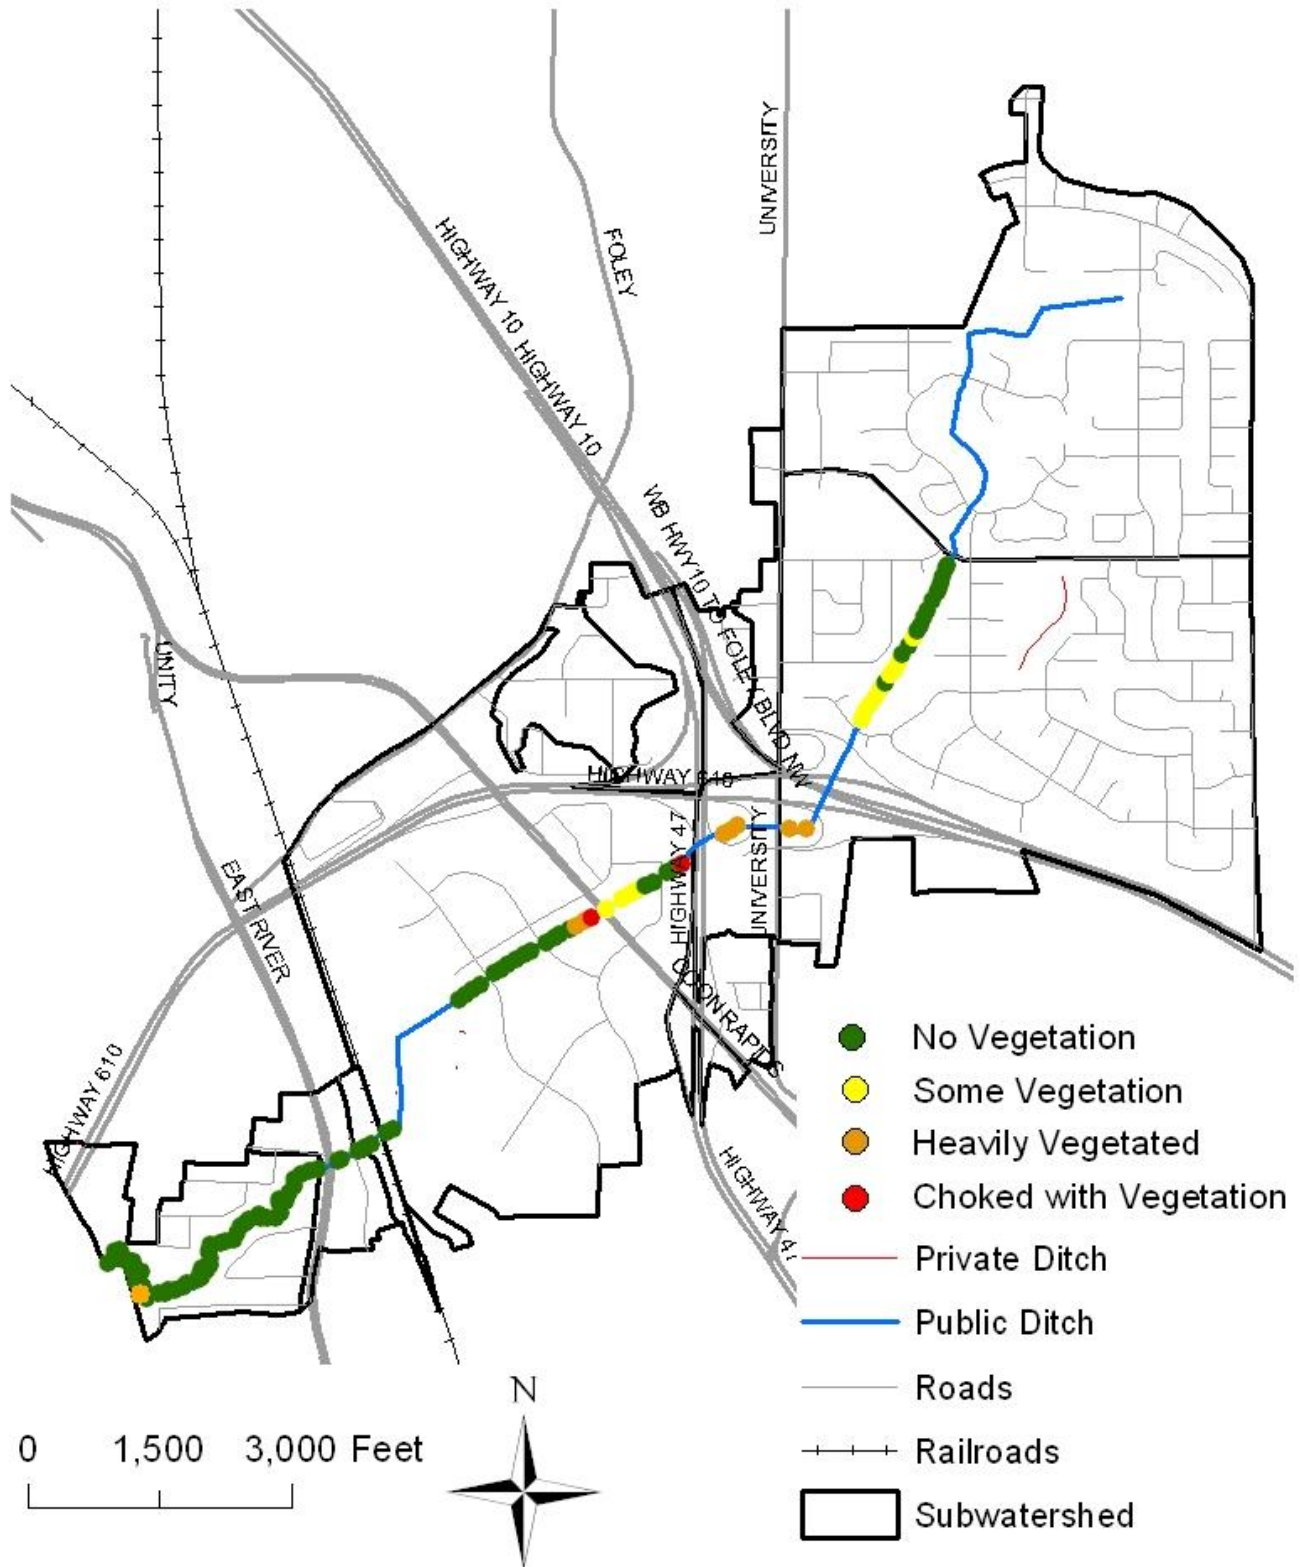
**Figure 5:** Pleasure Creek channel vegetation descriptions. Values resemble conditions at time of survey.

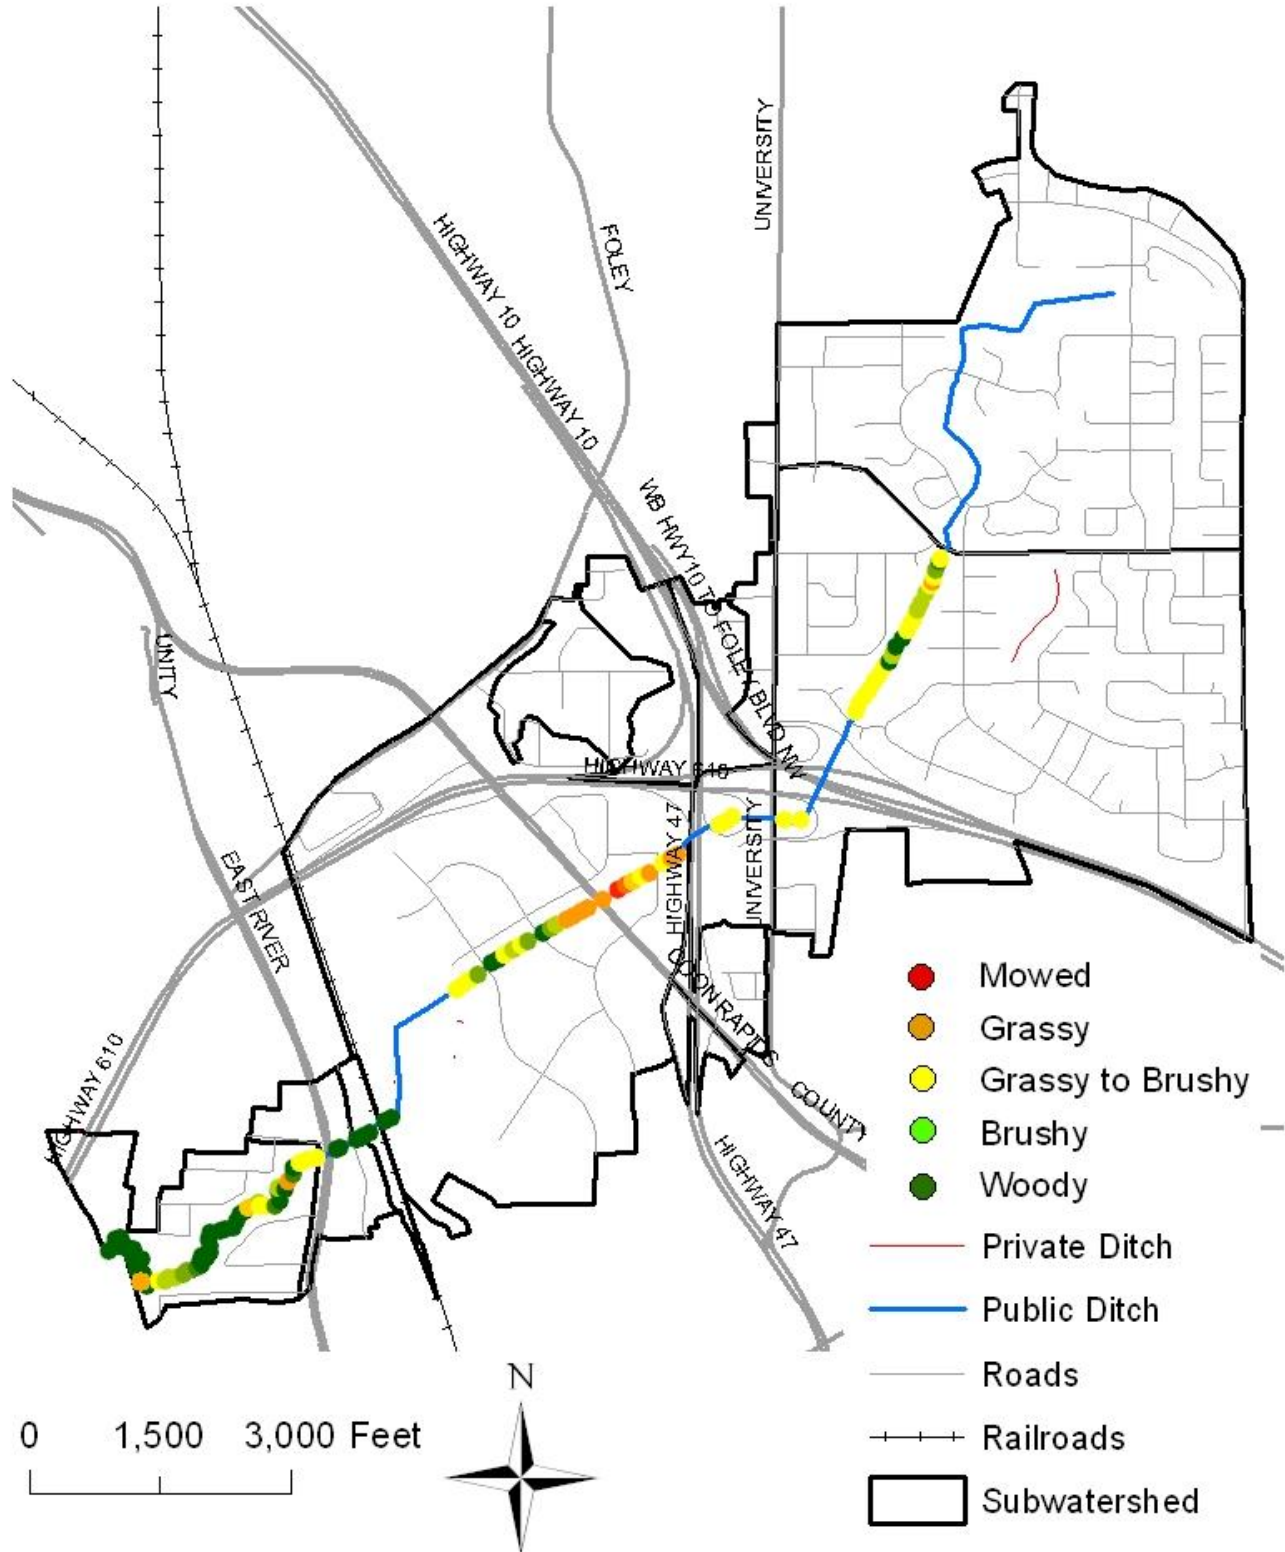
**Figure 6:** Pleasure Creek side slope vegetation descriptions. Values resemble conditions at time of survey. Legend descriptions ordered by severity.

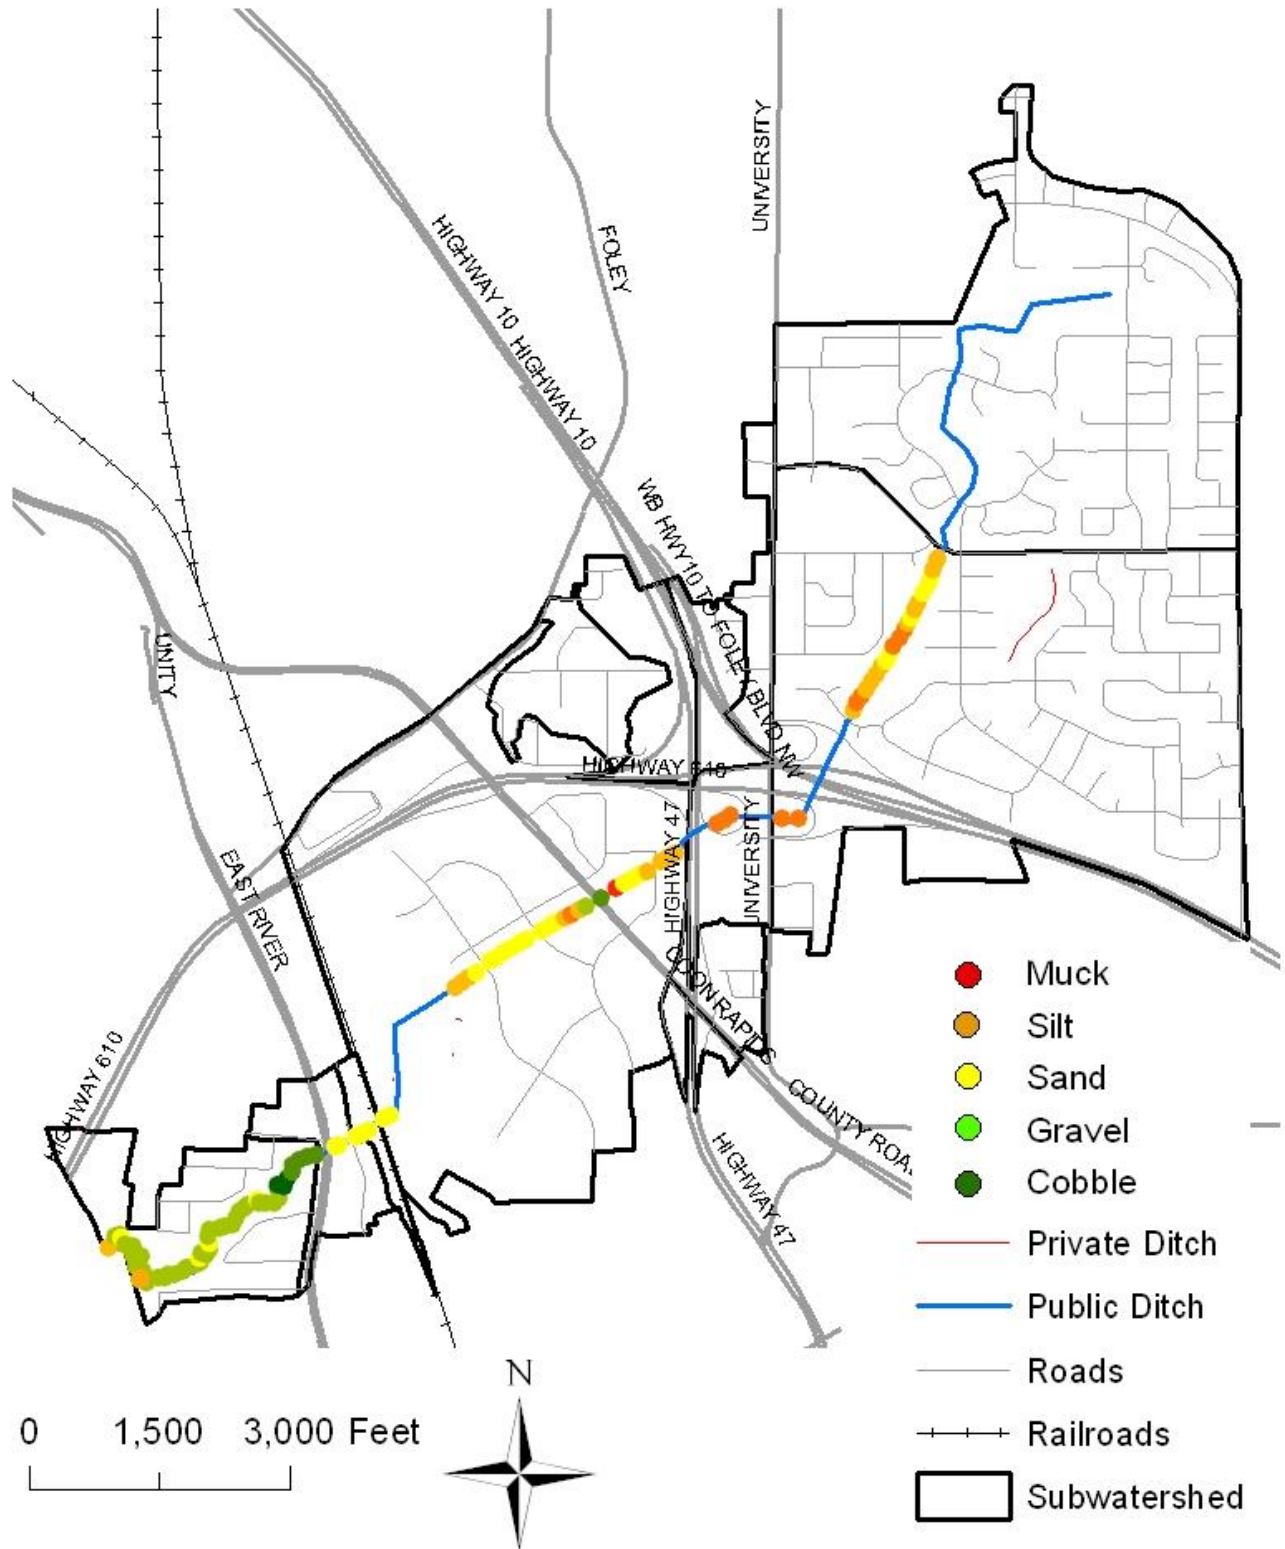
**Figure 7:** Pleasure Creek substrate descriptions. Values resemble conditions at time of survey. Descriptions ordered from small to large particles.

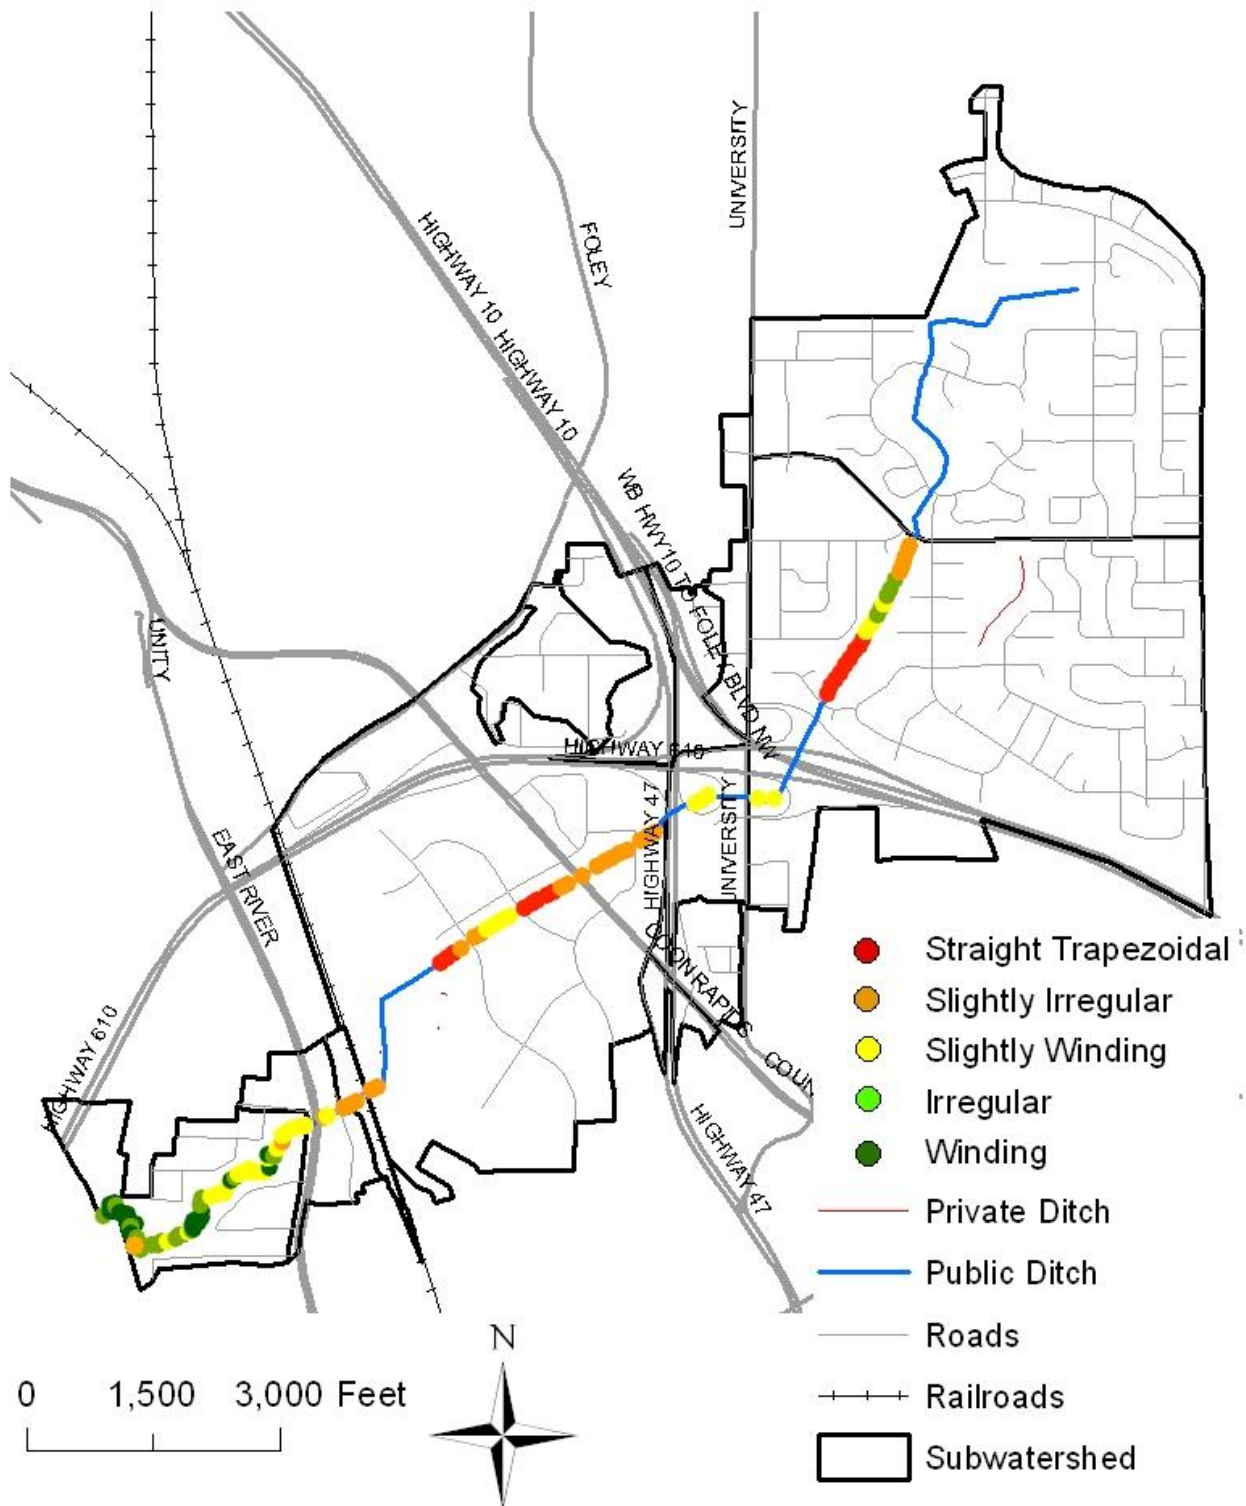
**Figure 2:** Pleasure Creek channel descriptions.  
 Values resemble condition at time of survey.
