Coon Creek Watershed District is a special unit of government in Anoka County that manages local water resources.

This document gives a How-To for one aspect of closing out your permitted project, having vegetation established on 70% of the disturbed soil from your project. Having this amount of permanent, perennial vegetation prevents erosion from polluting our waters.

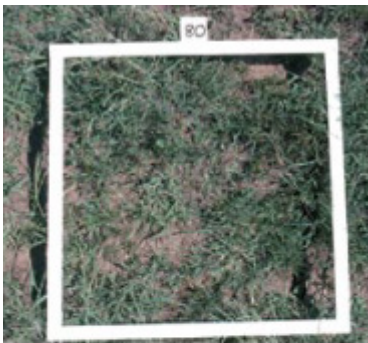
80% coverage

Visualize a square 18"x 18" in front of your feet and look vertically into the site to estimate the percentage of the area that is covered by plant material and litter. Do this repeatedly, like 5 times, and average out the results.

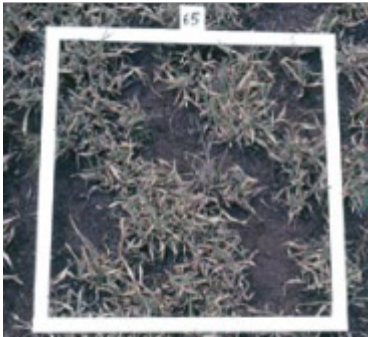
65% coverage

Hint: Imagine the square is divided into quarters, then mentally move all the bare areas into one section. If the bare areas fill less than one section, then the cover exceeds 75% of the area.

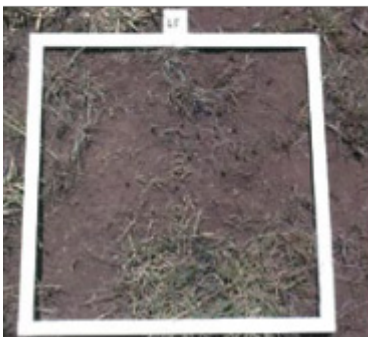
45% coverage
