Coon Creek Watershed District Watershed Restoration and Protection Strategy Report (WRAPS)

Mississippi River-Twin Cities Major Watershed

April 2016

Minnesota Pollution Control Agency

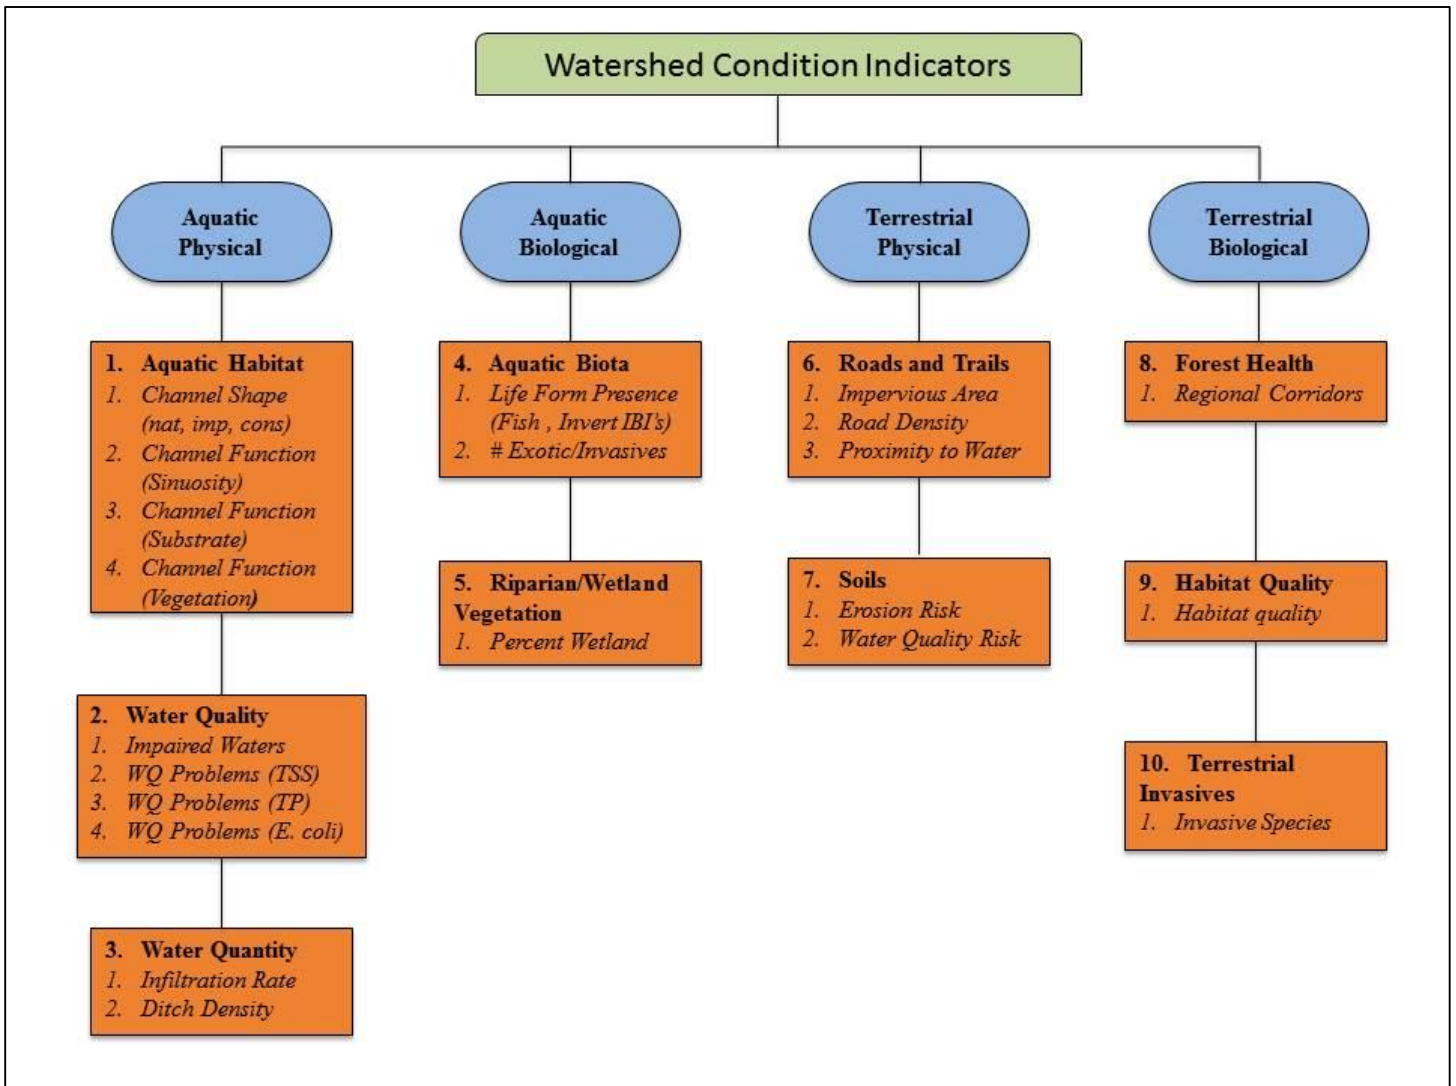
Figure 15 Conceptual model of Watershed Condition Classification assessment.

Each of the 10 indicators listed above were scored by averaging the individual scores for set of attributes within each indicator (Figure 15). For example, the “Aquatic Physical” process category contains an indicator for “Water quantity” condition. In this assessment “Water quantity” condition was determined by averaging scores from two attributes: (1) infiltration rate and (2) ditch density. Each indicator score was averaged again to determine the ecological process score.

After all four ecological process scores were determined; a weighted average was taken to determine the overall condition score using the following weighted scheme; aquatic physical (30%), aquatic biological (30%), terrestrial physical (30%) and terrestrial biological (10%). Use of a weighted average approach operates on the assumption that not all ecological process contribute equally to the overall watershed health
